## TESTS ON H-PILES DRIVEN TO ROCK

Garland Likins, President  
Pile Dynamics, Inc., Cleveland Heights, Ohio 44106

G.G. Goble, Chairman  
Department of Civil, Environmental and Architectural Engineering  
University of Colorado, Boulder, Colorado 80309

**Proceedings  
of the  
Thirty-Second Annual**

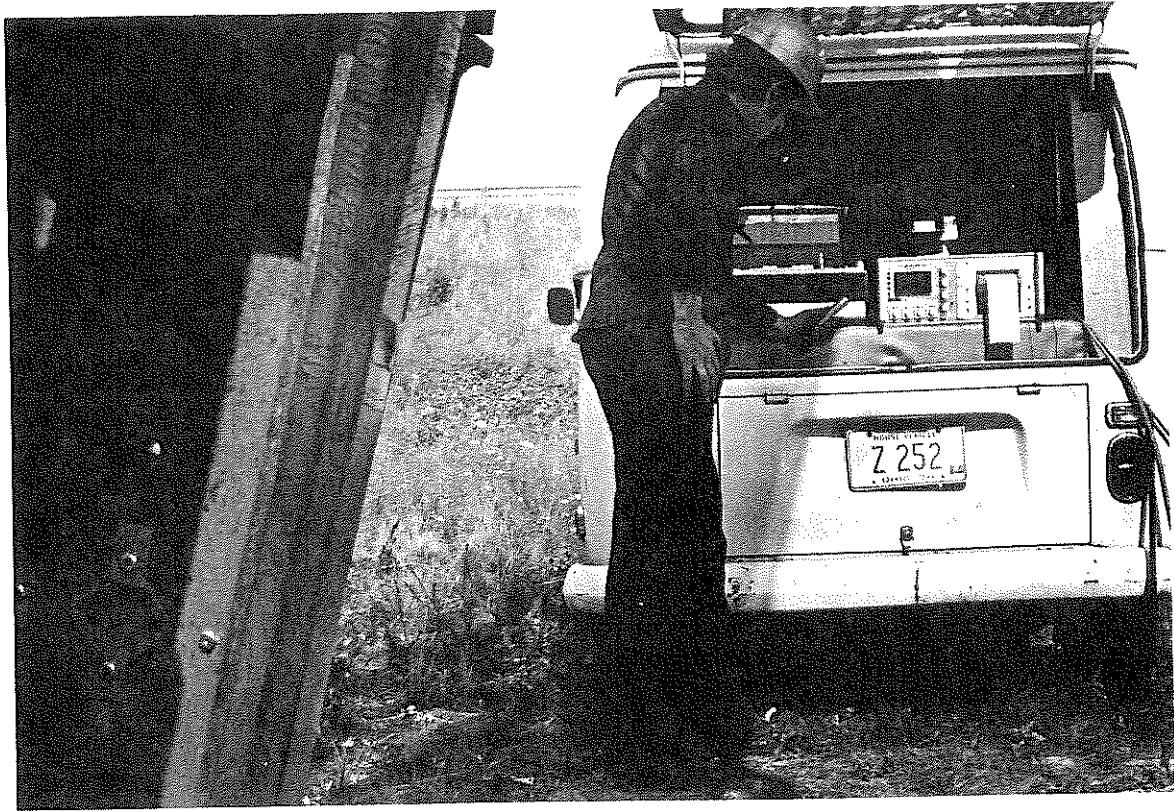
FIGURE 3 Case Method Pile Driving Analyzer and recording system with transducers on the pile (foreground left)

During driving, blow count was recorded as well as complete set-rebound records and for diesel hammers stroke or bounce chamber pressure. In addition, force and acceleration was measured at the pile top and processed by the Pile Driving Analyzer. Analog records of each hammer blow were recorded on magnetic tape. The transducers and recording system are shown in Fig. 3. Due to space limitation this recording and processing system will not be discussed further since it has been described extensively elsewhere (Ref. 2). The Case Method pile capacity is given in Table I.

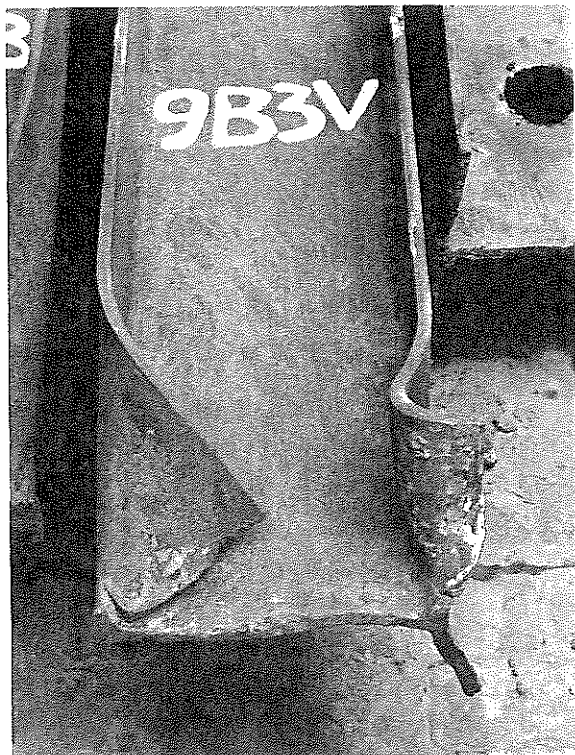
FIGURE 4 Sandusky Pile 9B3-V

Some of the extracted piles are shown in Fig. 4 through 12. The condition of the 520-P pile in Fig. 6 was typical of all of the piles that had point reinforcement. A back-hoe was used to excavate to within about 4 ft. of the tip to avoid additional pile damage during extraction. Even this depth of soil was sufficient to hold the tip and pull off some of the previously damaged section, as seen in Fig 5, 10 and 11. Some further comments are appropriate. Note that even though pile 520-B was badly buckled and probably was shortened by at least 3 ft, it still carried a static load of 354 kips which is associated with a stress of 28.5 ksi. The smallest failure stress was 9.6 ksi but that pile was further loaded to a stress of 12.4 ksi prior to discontinuing the test. Damage of the type shown in Figure 4 did not affect the pile capacity.

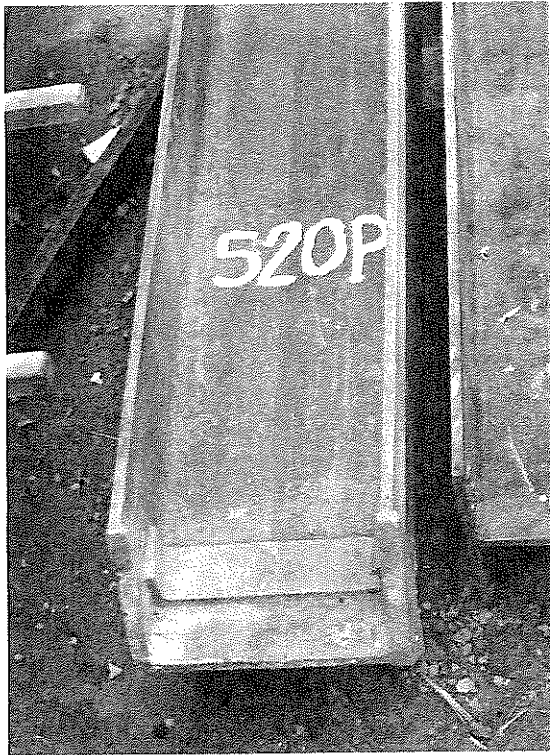
FIGURE 6 Sandusky Pile 520-P

10. Pile tip protection prevented tip damage at the hard bedrock site. Piles then failed structurally above ground in gross column buckling during driving. This above-ground column failure (which was removed prior to static testing) did not adversely affect the compressive static load test capacity.
