CASE Contd.

Integrity Testing

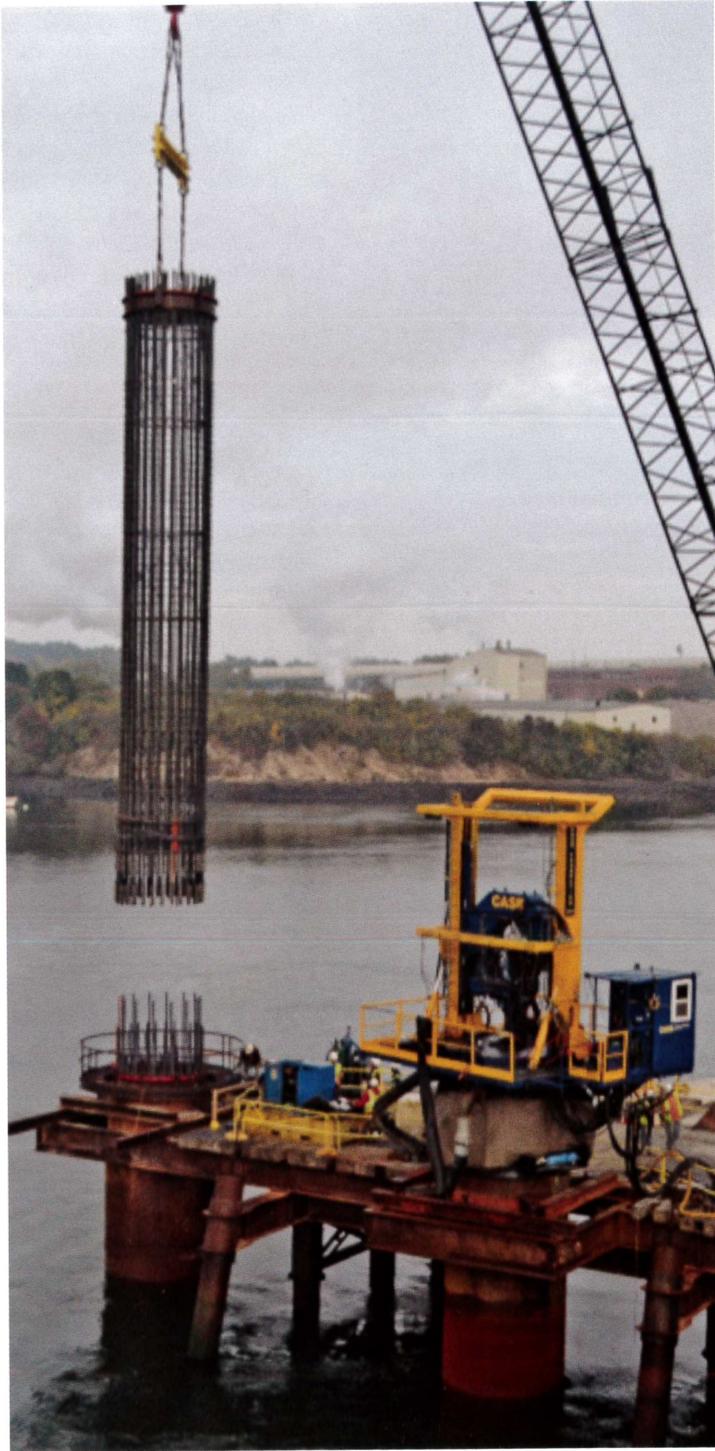
Figure 11: Reinforcing Steel Cage Placement.

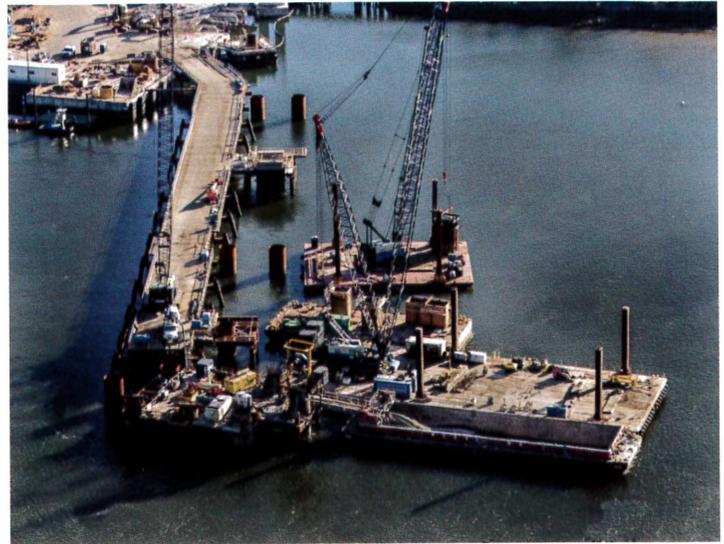
Figure 10: Wirth Set Up (courtesy of Richard Hopley Photography).
