Advancing Foundations: Augered Cast-in-Place Bridge Foundations

ERIC DUES, PE, SE, Gannett Fleming, Columbus, Ohio, and TOM MONACO, PE, Gannett Fleming, Akron, Ohio, and BENJAMIN WHITE, PE, GRL Engineers, Inc., Solon, Ohio

IBC 22-68

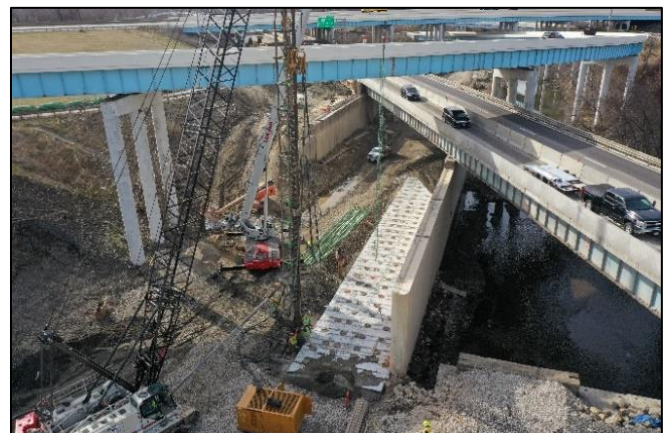
Photo 1: Phase 3 (Initial) ACIP Installation

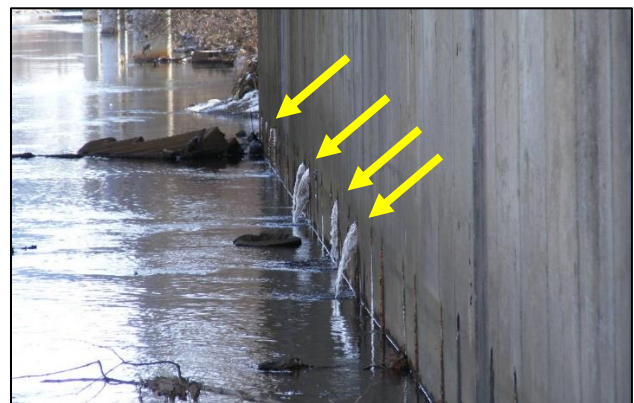
Photo 2: Constantly flowing forward abutment weep holes. Weeps are 3 feet above creek level and shown after 13 months of low rainfall.

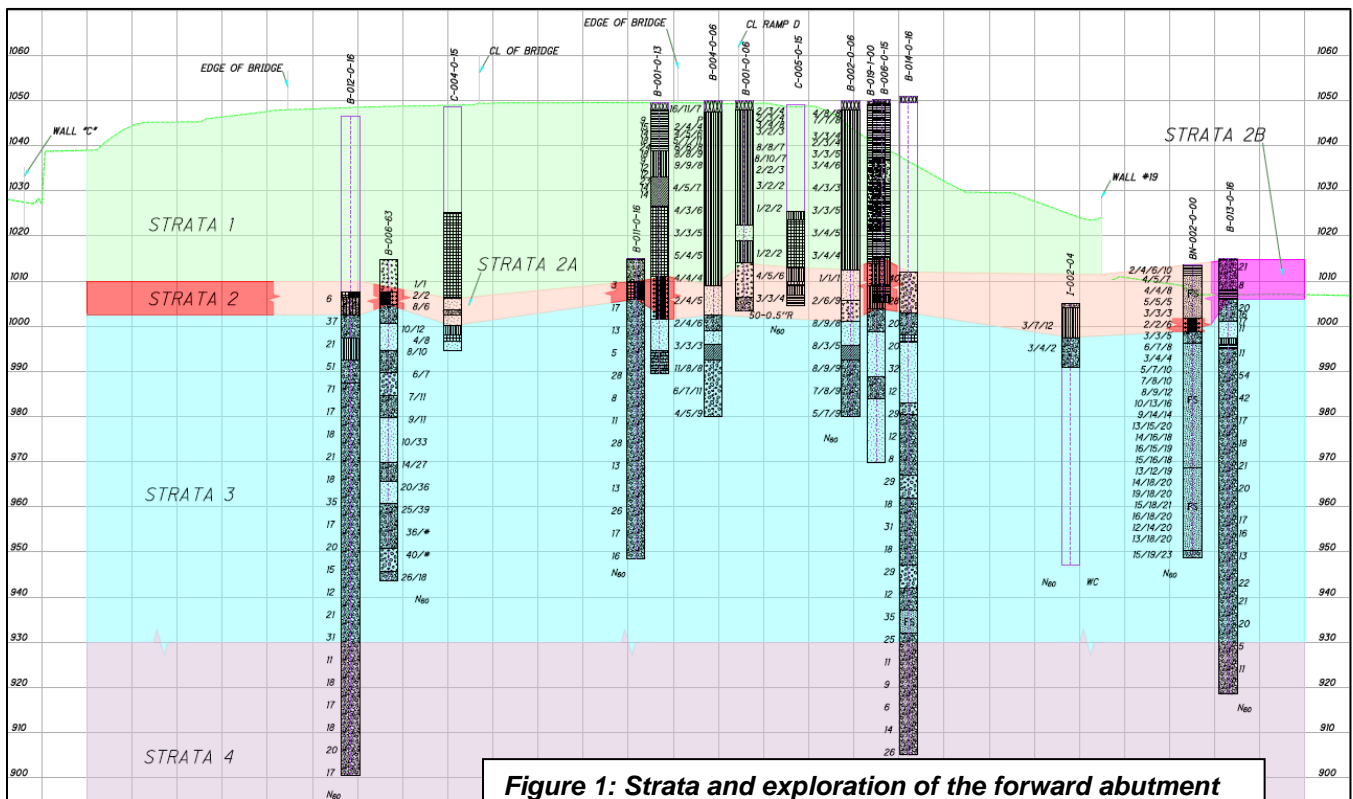
The charged conditions result from the differential in the pressure head between the head waters at an elevation of approximately

1100 feet and the local valley bottoms of approximately 800 feet and a confining layer of fill from the bridge construction starting at around elevation 990 to 1000. Based on the piezometer information the ground water has a spatially variable head. The maximum elevations found in the piezometers range between 1014.3 and 1017.1. It is important to understand that the near surface soil and embankment soils acts a confining layer in respect to the underlying aquifer. The confining layer can be called an aquitard or aquiclude. A confining layer is defined as a soil layer that allows much less water volume passage than the aquifer it overlays. When the confining layer is penetrated water is released up, under pressure, through the confining layer even though the confining layer itself is saturated. Thus, we see when the soil is saturated is at a greater elevation than the confined aquifer's potentiometric surface, the saturated soil prevents piping. In other areas, where the ground surface elevation is lower than the potentiometric surface elevation, potential for piping exists. These areas are the stream bed, the stream banks, beneath the footings of the structures, and to some extent behind the abutment wall. Perhaps most significantly, at the footings, penetrations from driven piles provide a pathway for the piping and seeps to develop. The groundwater works to reduce the frictional resistance of the steel piles by transporting water and fine material away from the piles, reducing the available geotechnical resistance of the frictional piles. This destabilizes the bridge foundation and allows it to move over time. This is consistent with the observation of many artesian seeps at the site, in and around the stream and substructures, including water piping vertically out of the pier foundation several feet above the stream surface.

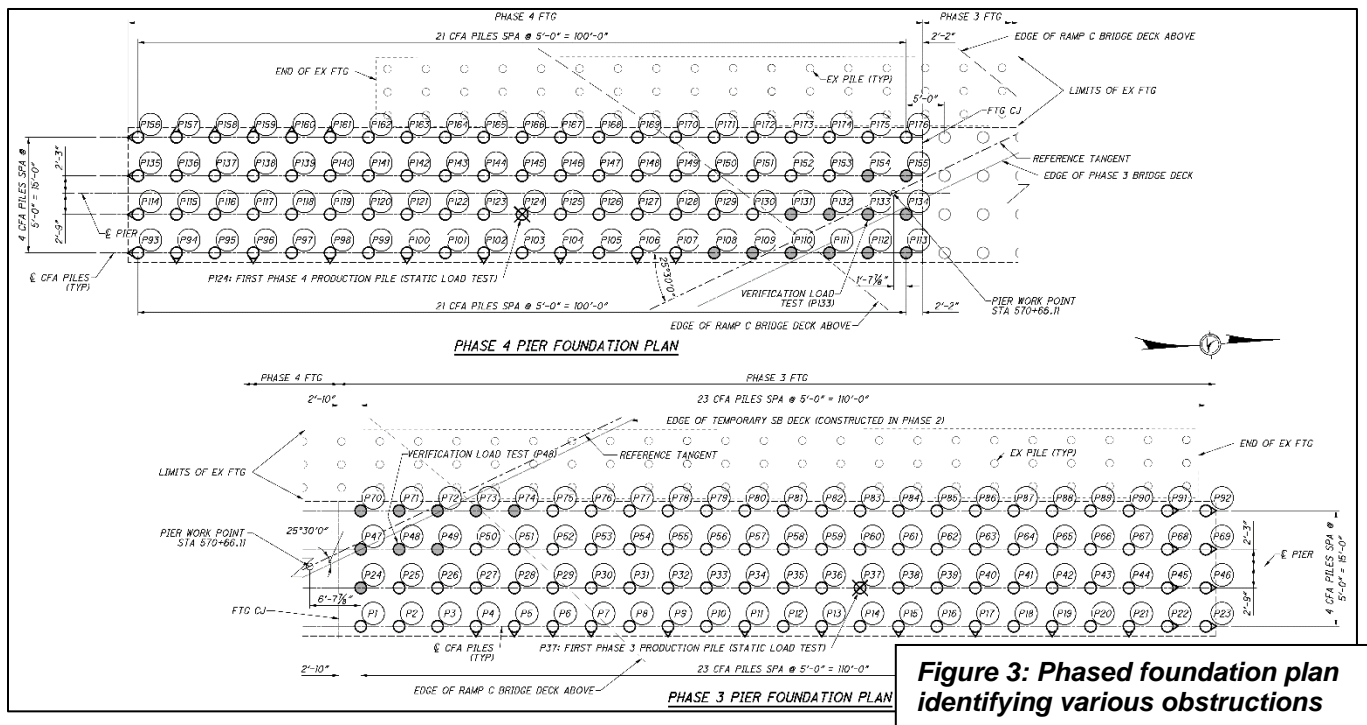
Figure 3: Phased foundation plan identifying various obstructions

ORIGINAL SHAFT CONSTRAINTS: Beyond the difficult subsurface, the drilled shaft pier foundation was complicated by the overhead obstructions of the in-service portions of the bridge, and an overhead ramp bridge. This resulted in phase-line shafts being offset 26 feet from the edge of the first phase of footing. It also resulted in a large corner of the first phase of footing being installed without a deep foundation element for support and thus the footing had to be cantilevered over the shafts and several shafts had very high loads and required depths. This cantilevered footing made drilled shaft installation difficult, costly and time consuming.

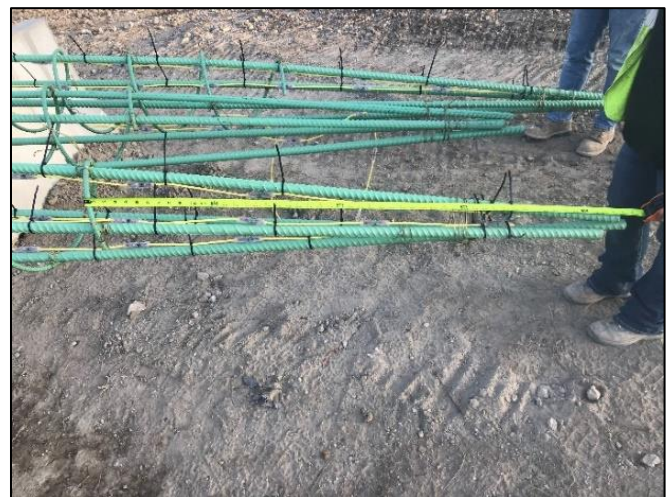
Photo 5: TIP instrumentation of rebar cage taper at bottom

Evaluation of the TIP data was complicated by multiple factors. First, the rebar cage was bundled at the bottom to taper the cage and facilitate installation through a fluid grout column (Photo 5). Second, the piles were extended to the top of the template, which was eight feet above the final top of pile elevation, while only the data over the production length of the piles needed integrity evaluation.

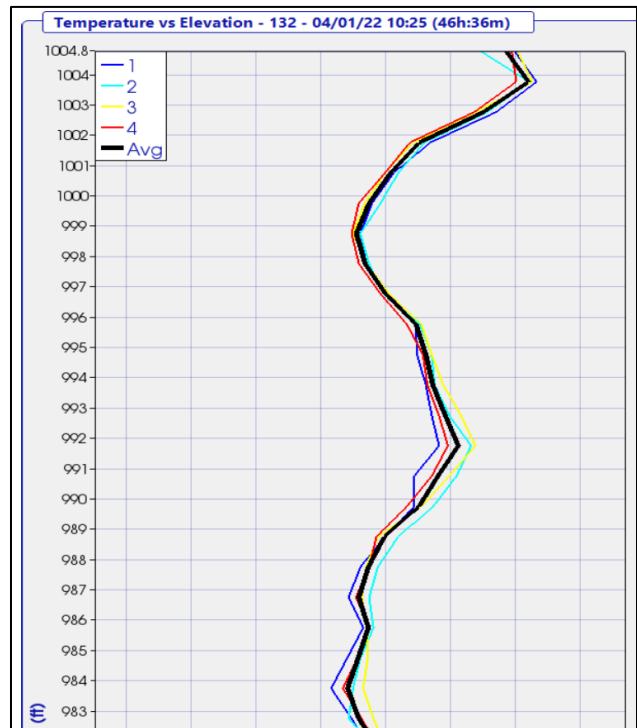
Figure 4: Example TIP Results, Wire temperature vs. depth at a specific time

To account for the extended length at the top, data above the cut-off elevation was removed from the analysis within the TIP-Reporter software. To account for the taper, an assumed typical temperature “roll-off” was applied. The temperature roll-off at the bottom is due to heat escaping both along the pile edge and bottom and is standard practice in evaluating TIP data. However, because the TIP sensors were physically closer to the center of the pile near the bottom, where the temperature is expected to increase, a mid-pile adjustment was applied to the data along with the roll-off correction. Because this required some assumptions, the roll-off and mid-pile adjustments for every pile were recorded and compared to evaluate consistency.

56 ACIP piles were tested using TIP, including both battered piles and piles installed using low clearance methods. Of those tested, only one pile indicated an integrity deficiency near the final top of pile elevation. Upon removal of the added length, this pile was chipped down to acceptable grout and formed back to pile cut-off elevation. Evaluation of the rebar cage alignment indicated that vertical piles maintained excellent alignment. The evaluation of the battered pile

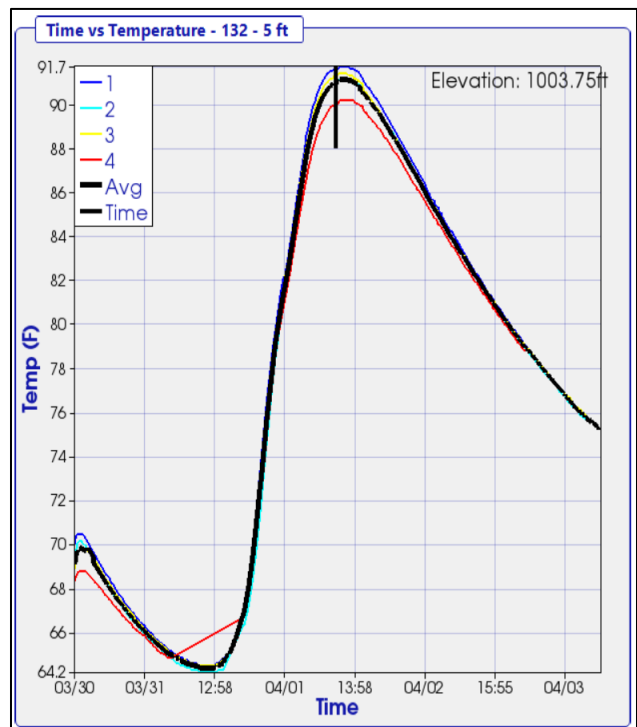
Figure 5: Example TIP Results, Wire temperature vs. time at a specific depth

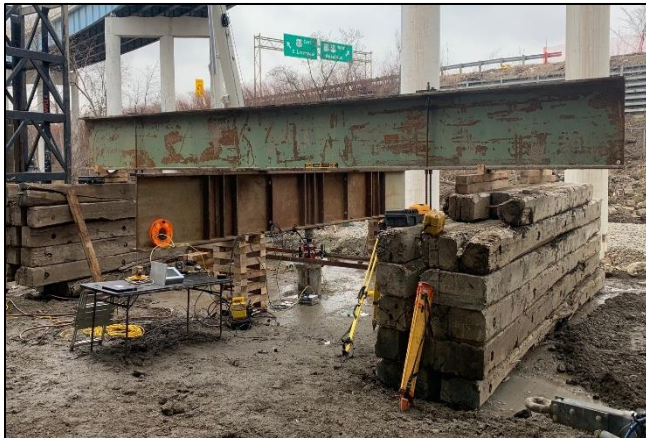
Photo 6: Static Load Test Set-up

DESIGN VALIDATION LOAD TESTING: the project did a static load test on 5/28/2020 to validate the initial design, prior to fully converting the foundation to ACIP foundation elements. The tested pile and reaction piles were laid out in the same proposed pattern of the foundation, so that the frame and results would correspond to the requirements of the production foundation.

Ultimately, the static load test, administered and documented by the project team onsite, resulted in very good results. The maximum load tested was 380 kips (which included some overburden resistance); the maximum factored resistance required of each pile was 132 kips. The test resulted in less than 0.4 inches of total axial movement of the pile at the max test load. During a 60-minute hold time at the max test load, the pile crept only 0.02 inches and rebounded to a total deformation of 0.25 inches, 10 minutes after the static test was completed.
