17TH ANNUAL MEMBERS' CONFERENCE

*Determination of Pile Lengths
under Existing Structures*
M. Hussein, G. Likins, and G.G. Goble

DETERMINATION OF PILE LENGTHS UNDER EXISTING STRUCTURES

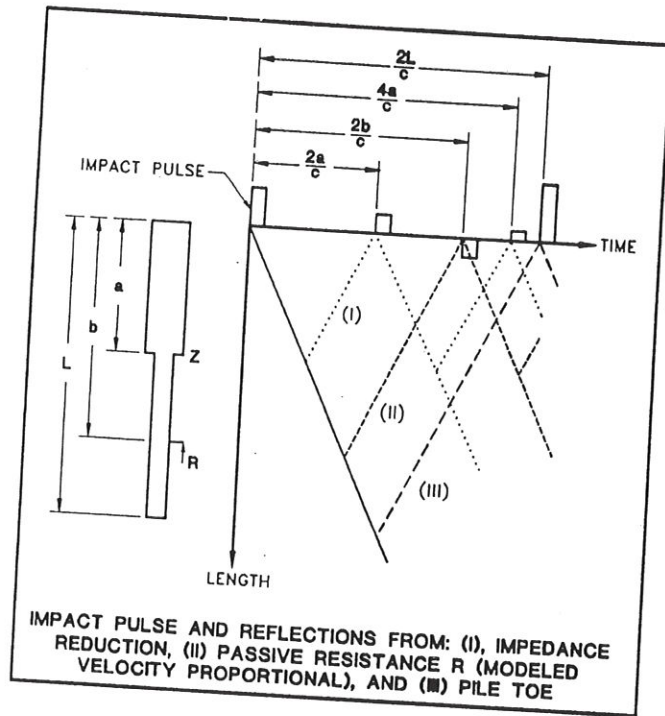
Figure 1 shows that when a compressive downward travelling wave encounters an impedance reduction at a distance "a" below the pile head, an upward travelling tension wave is generated that arrives at the pile head a time $2a/c$ after impact. The figure also shows that an upward travelling compression wave generated by soil resistance R at location "b" is observed at the pile head at time $2b/c$ after impact. Other reflections observed at the pile head are those from the pile toe at $2L/c$ and the secondary impedance reflection at $4a/c$.

FIGURE 1: IMPACT AND WAVE REFLECTIONS AT PILE HEAD

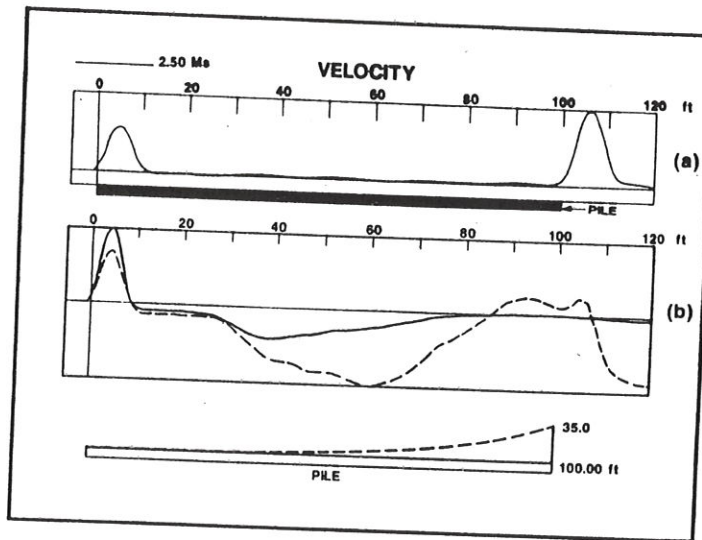
FIGURE 2: PILE HEAD VELOCITY RECORDS FOR A PRE CAST CONCRETE PILE BEFORE (A) AND AFTER (B) DRIVING

For normal applications, where pile heads are exposed, pile preparation simply involves smoothing a small area at the pile head. The accelerometer is attached to this smoothed area using a jell type material and the pile head is lightly tapped by the hammer. The acceleration record created by the impact is integrated and the resulting velocity record is displayed on the P.I.T. screen and then plotted on paper. The record versus time is converted to a length scale for ease of interpretation using the stress wave speed. Other arrangements are necessary for piles with inaccessible tops as described below.

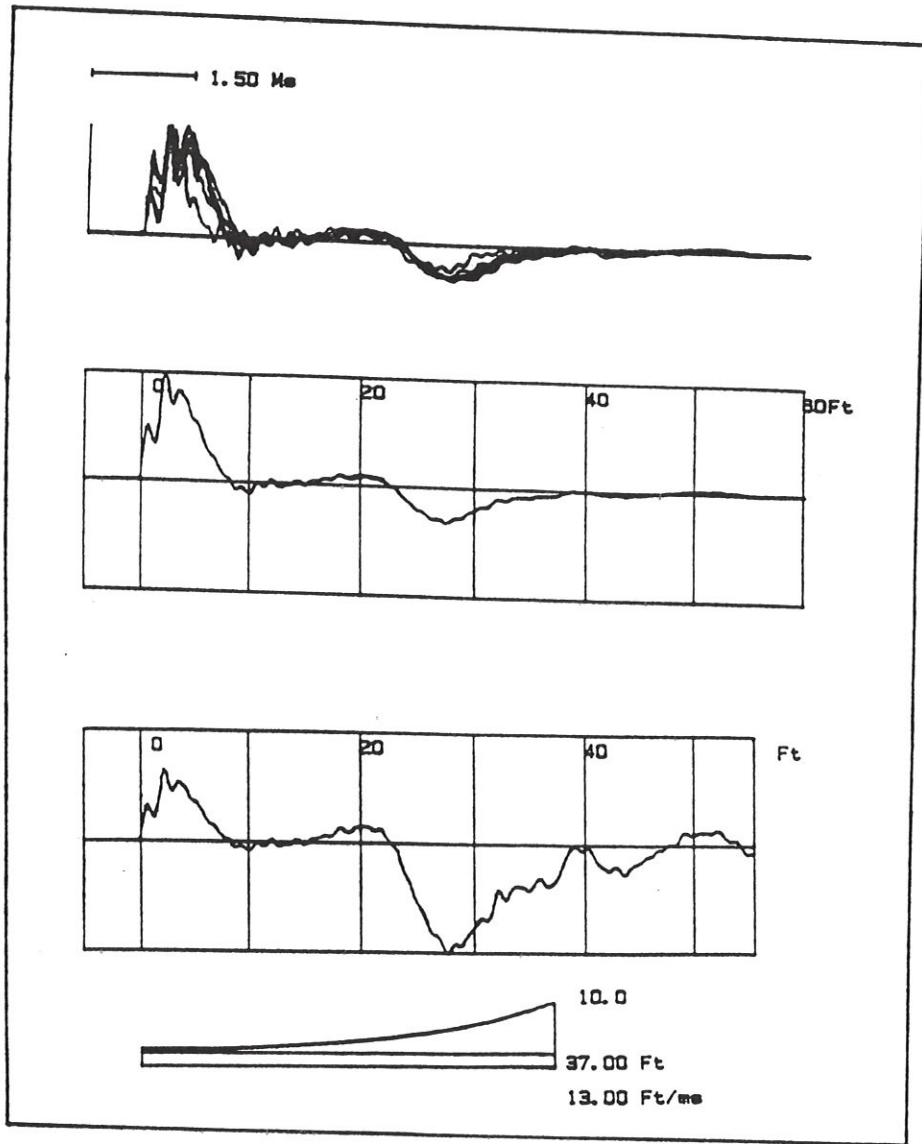
Low strain testing results of one pile are shown in Figure 3. The figure shows superimposed velocity records of five blows (top), their average (middle), and the final amplified record result (bottom) with predicted length, wave speed and amplification function. As mentioned before, the time to pile length transportation was accomplished by multiplication with one half of the stress wave speed.

This record indicates significant skin friction starting approximately 13 ft below ground level (22 ft below top of cap beam where data was obtained), and a distinct reflection, interpreted as the pile toe, at 37 ft below the top of the cap beam (corresponds to a pile toe penetration of approximately 28 ft).

FIGURE 3: CASE 1 - PILE HEAD VELOCITY HISTORY OF FIVE HAMMER IMPACTS (TOP), THEIR AVERAGE (MIDDLE), AND THE AMPLIFIED AVERAGED RECORD (BOTTOM) WITH PREDICTED LENGTH, WAVE SPEED AND AMPLIFICATION FUNCTION.

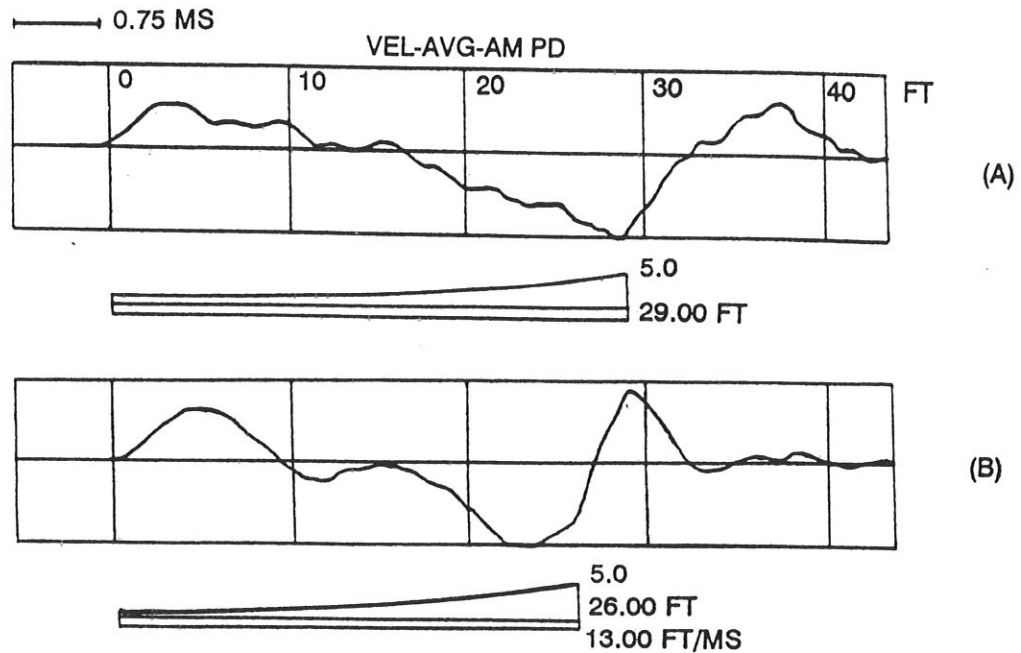
Subsurface conditions can be described as sand (with SPT N-values increasing from 5 to 17) to a depth of 12 ft, over silty sand (N-values of 20) to a depth of 28 ft, over silty clayey sand (N-values of 6). P.I.T. testing was performed on all four piles. Each pile was tested twice, once with the accelerometer attached to the top of the cap axially in line with the pile shaft, and later again with the accelerometer attached to the side of the pile below the bottom of the cap. In all cases, hammer impacts were applied to the top of the caps directly above each pile. Figure 4 presents velocity records for the two tests conducted on the same pile. Both records indicate wave reflections from the pile toe. The reflection location (29 and 26 ft) are consistent considering the difference in locations of the accelerometer. Tests on all four piles showed similar results indicating pile penetrations of approximately 24 ft below grade and noticeable soil resistance over the lower 10 ft, which is consistent with the soil conditions.

FIGURE 4: PILE HEAD VELOCITY RECORDS FOR CASE 2,, ACCELEROMETER ON TOP OF PILE CAP (A), AND ALONG PILE SHAFT (B)

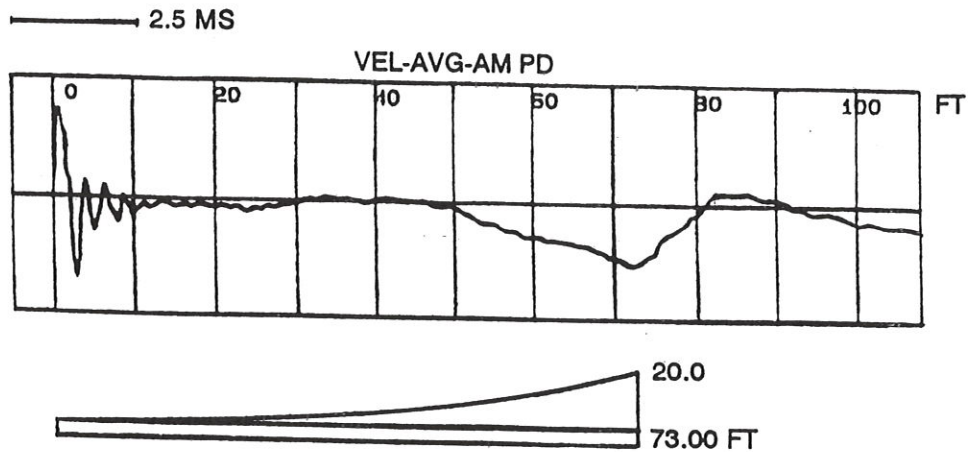
FIGURE 5: P.I.T. RESULTS, CASE 3

Along with geotechnical studies, a P.I.T. investigation was conducted in the structural integrity and the length of the piles under the structure. The accelerometer was attached to the side of the pile and the pile was tapped directly above the accelerometer location. As indicated by Figure 5, the pile toe reflection is evident at a location of 73 ft. Thus, testing verified pile lengths and satisfactory pile integrity. The observed excessive settlements had to be caused by reasons other than improper pile installation.
