LOAD TESTING FOR ACCEPTANCE OF SHAFTS WITH QUESTIONABLE INTEGRITY – CASE STUDIES

White, Benjamin, GRL Engineers, Inc., Cleveland, OH, USA, 216-831-6131, bwhite@grlengineers.com
Slomski, Stephen, Ohio Department of Transportation, Columbus, OH, USA, 614-466-4318, Stephen.slomski@dot.ohio.gov
Klausing, Brad, GRL Engineers, Inc., Cleveland, OH, USA, 216-831-6131, bklausing@grlengineers.com

Case Study #1 – Single Span County Road Bridge Replacement

Case Study #2 – Three Span County Road Bridge Replacement

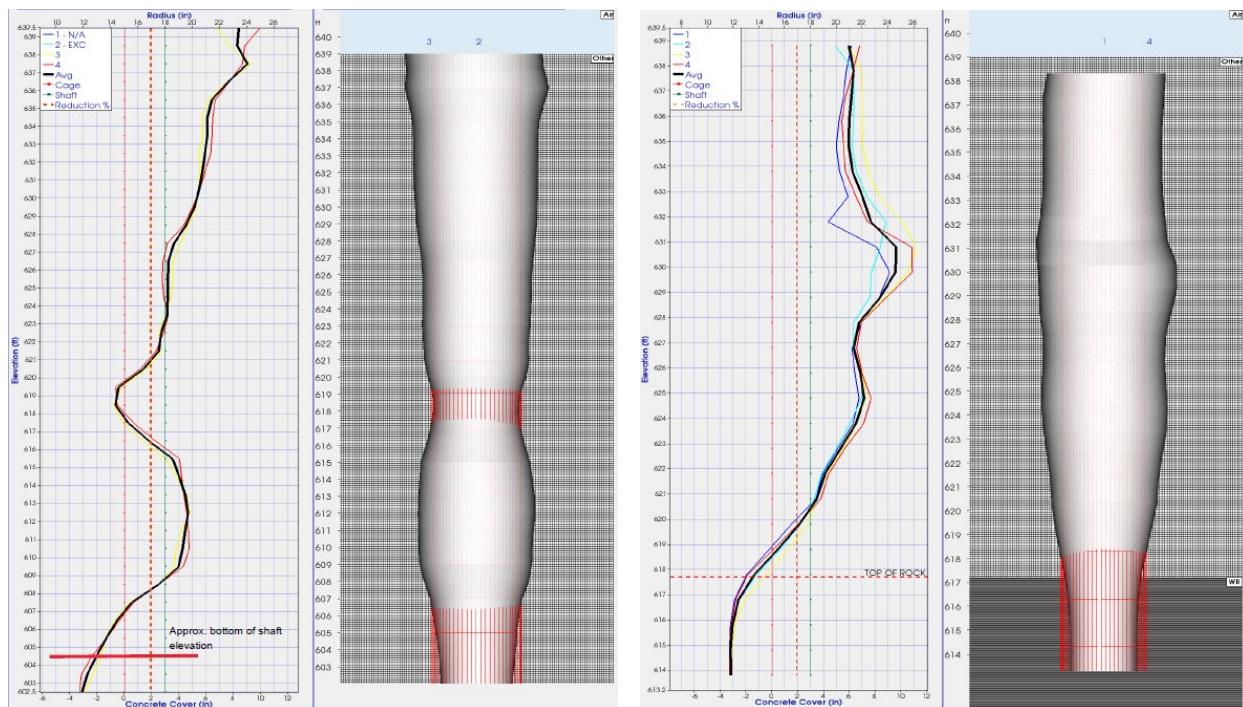
Three shafts, two at the rear abutment and one at the forward abutment, were instrumented with TIP wires on the reinforcing cages to collect the TIP data for the evaluation of shaft integrity. Evaluation of the three TIP testing results indicated similar anomalies in all three shafts over the bottom 3 to 5 feet of the shafts. Based on the elevations and the TIP results, it also appeared the reinforcing cage had sunk into the soil below the base of the shaft. In addition, one shaft also had an anomaly at approximately the midpoint of the shaft. Figure 1 presents the TIP results of effective radius vs depth and a 2-dimensional model of the shaft with the shaft exterior surface overlayed on the reinforcing cage and generalized soil profile for both shafts.

Fig. 1: TIP Results Indicating Anomalies at the Base and Near the Midpoint of Shaft 1 (Left) at the Rear Abutment and Near the Base for Shaft 8 (Right) at the Forward Abutment

The anomalies could be caused by changes in geometry of the shaft, but this was unexpected. Concrete quality issues could arise from soil inclusions or contamination of the concrete by water and cuttings, but no observations during installation indicated these issues. The contract specifications required that anomalies were to be evaluated by coring the concrete and testing its strength. If the strength was found to be deficient, then the contractor had to prepare a remediation plan. However, since the anomalies appeared to be across the full section, including outside the reinforcing cage, coring was deemed to not be able to provide sufficient information for repairs or to evaluate reduced capacities for the shafts. In addition, all ten shafts were suspected of having similar anomalies, because construction methods and observations did not vary among the shafts. Therefore, all the shafts were considered to be deficient and required a remediation plan. Due to the spacing of the shafts, adding more drilled shafts to the abutment was impractical.

With the understanding that integrity testing results indicated significant anomalies over the bottom 3 to 5 feet in each of the shafts, the shafts were modeled as approximately 4 feet shorter in the signal matching analysis, which created a reasonable match. In addition, an impedance reduction was evident in the Shaft 1 results which corresponded to the integrity testing results and was modeled in the signal matching software.

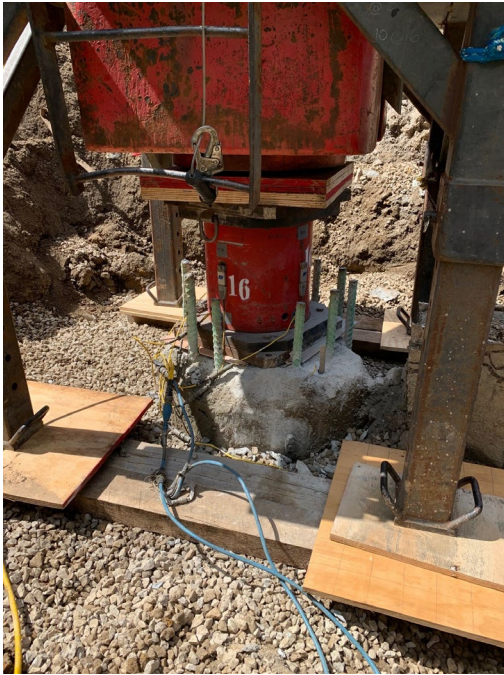
Fig. 3: Shaft instrumented for HSDT

HSDT was performed on both shafts. A drop hammer system with a 9-kip drop weight was used to provide the impacts to the shafts. After preparing and instrumenting the shafts, three to four impacts were applied to each shaft with increasing drop heights. The drop heights ranged from 8 to 24 inches. After each impact, the shaft's set was measured using an optical level and a scale attached to the shaft.

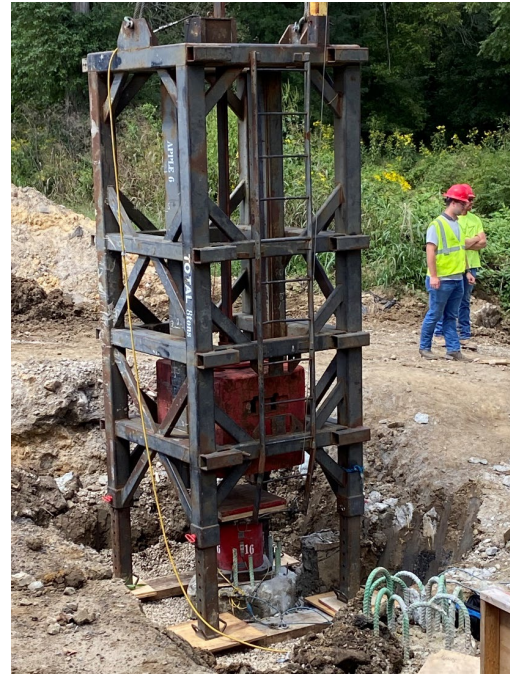
Fig. 4: Drop hammer system positioned on shaft

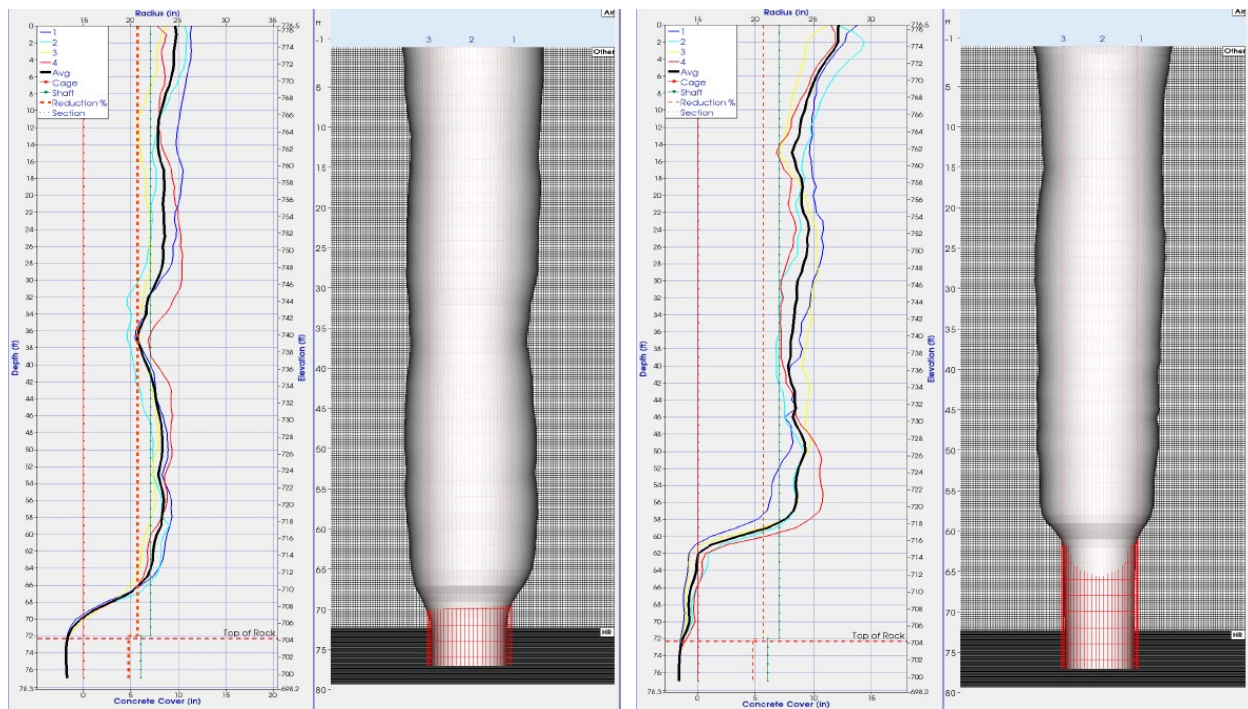
Documentation and details of the shaft installation provided to the testing consultant were minimal. A tremie was used to place the concrete, however, the tremie pipe onsite was measured to be 60 feet in length, while the forward abutment shafts were designed for a length of approximately 75 feet. Shaft bottom cleanout procedures were not provided. TIP results indicated very little temperature increase in the bottom 10 feet and 20 feet of shafts 19 and 20 respectively. Both results indicated anomalies in the bottom of the shafts, in both cases, the anomalies extended above the reported top of rock. Figure 5 presents the TIP results of effective radius vs depth and a 2-dimensional model of the shaft with the shaft exterior surface overlaid on the reinforcing cage for both shafts.

Fig. 5: TIP Results Indicating Anomalies at the Base of Shaft 19 (Left) and Shaft 20 (Right)

Similar to Case Study #1, the anomalous area was to be evaluated through coring per the project documents. Again, however, the anomalies appeared to be across the entire shaft section, and remediation may not be effective. The contractor and testing consultant elected to propose performance testing through HSDT to confirm that the shafts, as installed, could provide the required factored loads shown in the plans. Again, the designer and the owner accepted the proposed testing to evaluate the ultimate resistance of a shaft at each abutment which would determine the magnitude of any necessary remediations.

With the understanding that integrity testing results indicated significant anomalies over the bottom 10 to 20 feet, the shafts were modeled as approximately 10 and 20 feet shorter in the signal matching analysis, which created a reasonable match. The mobilized soil resistances under the highest energy impacts were 615 kips and 590 kips for shafts 19 and 20, respectively. The shaft resistance mobilized for both shafts was approximately 540 kips, which exceeded the required factored load, but was completely neglected during design. Note that the factored side and tip resistances were assumed to only be provided from the bottom 4 feet of the rock socket and in end bearing for the forward abutment shafts. It appears that the soil resistance above the locations assumed to provide soil resistance was enough to support the structure. As the mobilized soil resistance was greater than the required factored load, the shafts were determined to be acceptable.

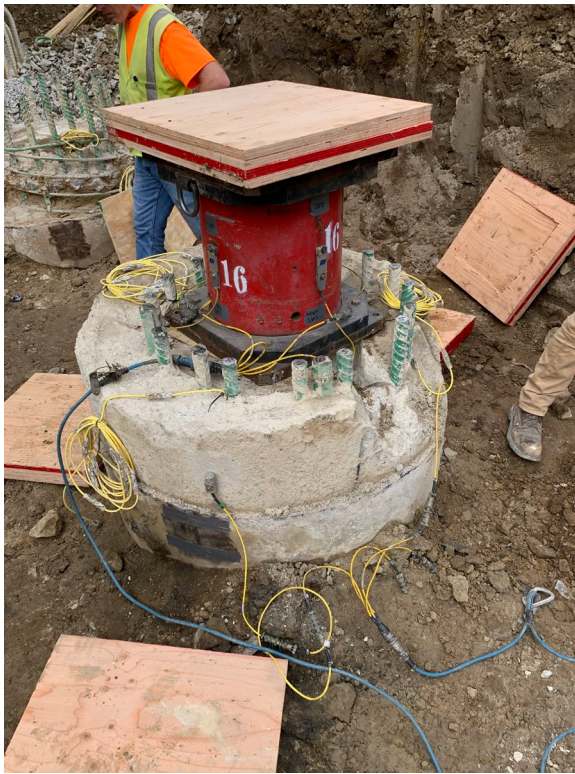
Fig. 7: Shaft instrumented for HSDT

HSDT was performed on both shafts. The same drop hammer system from Case Study #1 was used to provide the impacts to the shafts. After preparing and instrumenting the shafts, four impacts were applied to each shaft with increasing drop heights. The drop heights ranged from 10 to 30 inches. After each impact, the shaft set was measured with an optical level and a scale attached to the shaft.

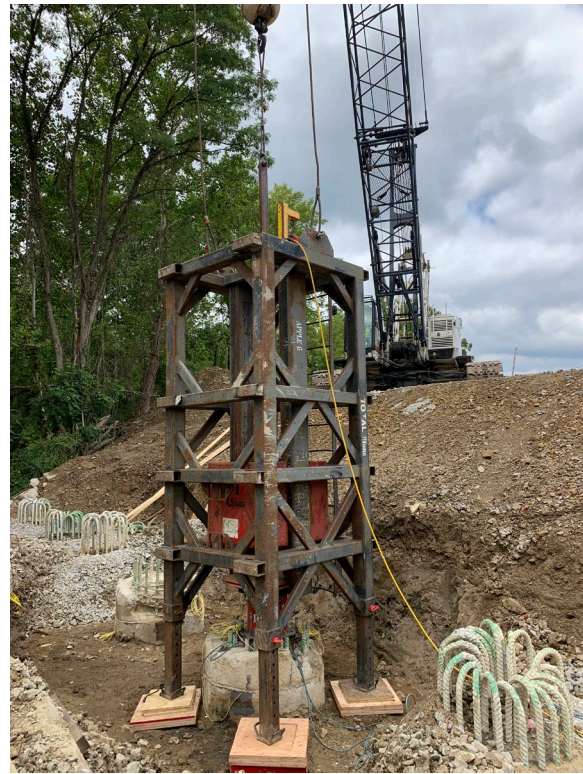
Fig. 8: Drop hammer system positioned on shaft
