PARKING GARAGE SUPPORTED ON RE-USED CAISSONS AND COMPOSITE CAISSON-MICROPILES

ABSTRACT

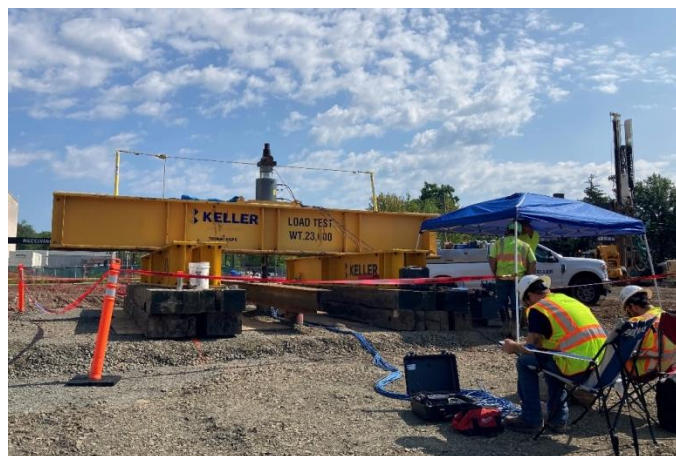
Fig. 1. Micropile Tension Test Setup (Test #1).

The test micropiles were the same size as the production micropiles, except a full length #32 center bar was installed to accommodate the maximum designated test loads. One of the challenges of tension load testing was locating available jacks, load cells, and accessories that could accommodate a #32 bar (4-inch diameter). Fortunately, the available equipment conforming to ASTM standards was eventually located, with the exception to a hemispherical bearing plate, which was allowed by the Design Team not to be used. At a maximum test load of 900 kips, the two test piles deflected between 1.7 and 1.8 inches, in which about 1.3 to 1.4 inches was elastic deflection of the steel. The load testing confirmed an allowable bond strength of the bedrock of 65 psi, which was higher than the original bidding bond strength of 50 psi and production pile socket lengths were reduced by about 25%.

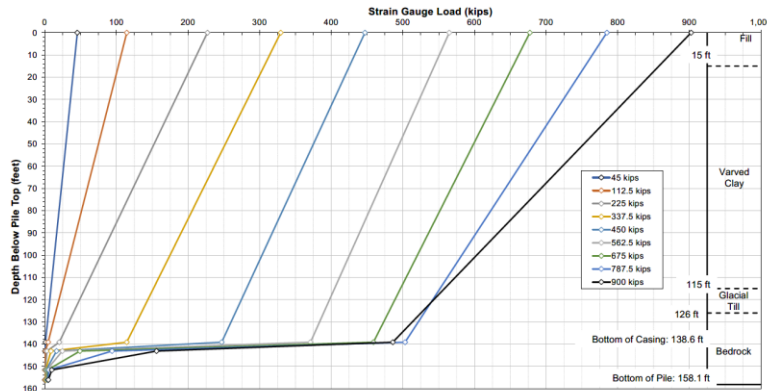
Fig. 2. Internal Force Versus Depth Determined from a Tensile Static Load Test.

project’s specifications required several levels of strain gauges in the rock socket due to the length of the pile and concern for gauge survivability during installation. The pile casing was extended through the fractured rock. Since the test was run in tension, the effects of grout cracking on the pile elastic modulus were reasonably approximated in computing pile internal forces. The computed internal forces determined from strain measurements for one of the test piles is shown in Fig. 2.

For each test pile, at least one set of strain gauges in the rock socket was non-functional after the installation of the rebar. The strain gauges were bench-checked prior to installation and during the process of installation, however damage still occurred. The rebar was installed in 20-foot segments due to the weight of the #32 bar and the cables needed to be kept clear of the rebar during splicing, but then secured to the rebar after splicing. The process of splicing and potential for kinking/cutting the cables on the outer casing was assumed to be the cause of damage.

Measured strains in the Glacial Till and Varved Clay strata were neglected from the computed internal force profiles to provide an estimated average resistance over the cased zone. The geotechnical resistances within these strata were not directly accounted for in the foundation design, however strain gauge instrumentation was implemented for potential redundancy and prudence in assessing the load-distribution characteristics along the full pile lengths. Overall, an activated bond stress of 130 psi was conservatively estimated in the competent rock which resulted in the allowable value of 65 psi used for design.

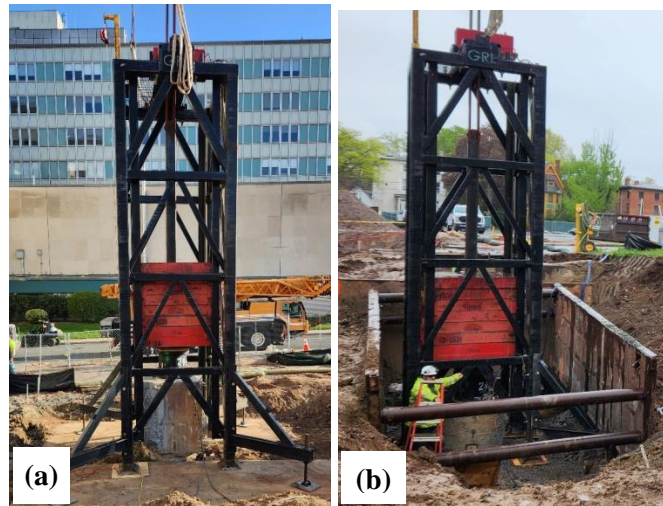
Fig. 3. Imagery of HSDLT on 3-foot-diameter caissons: (a) TS3-D1.0. (b) TS12-A3.2.

Complications were incurred for interpretation of the dynamic measurements, as well as drop weight system setup due to the geometric changes near the instrumentation locations. The quality and size of the foundation caps varied across site. A 4-foot by 4-foot square cap was exposed for most 3-foot-diameter caissons. Four 4.5-foot-diameter caissons included a 5.5-foot-diameter circular cap, while the other two caissons were exposed with a 5.5-foot wide square cap. The enlarged square cap was not anticipated prior to equipment mobilization, primarily since excavations were being performed concurrent with the dynamic testing, which required modifications to the drop weight system. The cap was completely

removed for one 3-foot-diameter caisson (TS12-A3.2) which accommodated dynamic measurements directly on the caisson head. Figure 3 and Fig. 4 present several example images for HSDLT conducted on the 3- and 4.5-foot-diameter caissons, respectively.

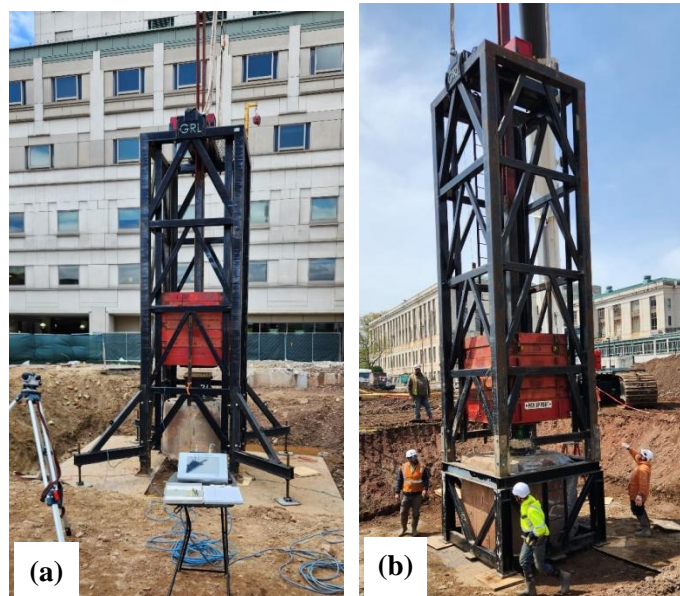
Fig. 4. Imagery of HSDLT on 4.5-foot-diameter caissons: (a) TS1-B1.0. (b) TS11-C8.1.

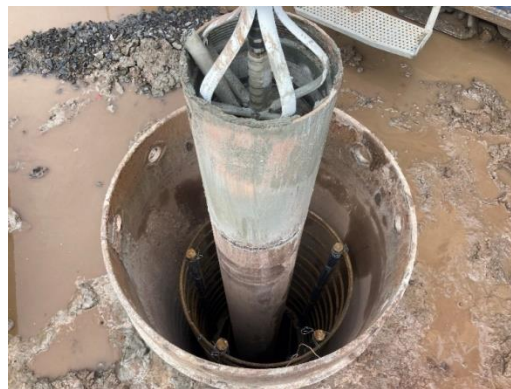
Fig. 5. Composite caisson-micropile prior to concrete placement.

The caisson installation proceeded with the remaining spoils and grout above the plug removed from inside the temporary casing by means of vacuum-excitation. It should be noted that this method would have been unable to excavate spoils if the bottom of shaft was much deeper than 30 feet. Once the hole was cleaned, the cage was set to the bottom and concrete was poured while pulling the temporary casing. Figure 5 shows the cage in place prior to final concrete placement.
