# Infrared Thermal Integrity Testing Quality Assurance Test Method to Detect Drilled Shaft Defects

WSDOT Research Report

FINAL REPORT

1. REPORT NO. **WA-RD 770.1**	2. GOVERNMENT ACCESSION NO.	3. RECIPIENTS CATALOG NO
4. TITLE AND SUBTITLE Infrared Thermal Integrity Testing Quality Assurance Test Method To Detect Drilled Shaft Defects		5. REPORT DATE *June 2011*
		6. PERFORMING ORGANIZATION CODE
7. AUTHOR(S) G. Mullins and D. Winters		8. PERFORMING ORGANIZATION REPORT NO.
9. PERFORMING ORGANIZATION NAME AND ADDRESS University of South Florida 4202 E. Fowler Avenue Tampa, FL 33620		10. WORK UNIT NO.
		11. CONTRACT OR GRANT NO. GCA5855
12. CO-SPONSORING AGENCY NAME AND ADDRESS Washington State Department of Transportation Transportation Building, MS 47372 Olympia, Washington 98504-7372 Research Manager: Kim Willoughby 360.705.7978		13. TYPE OF REPORT AND PERIOD COVERED *Final Report*
		14. SPONSORING AGENCY CODE

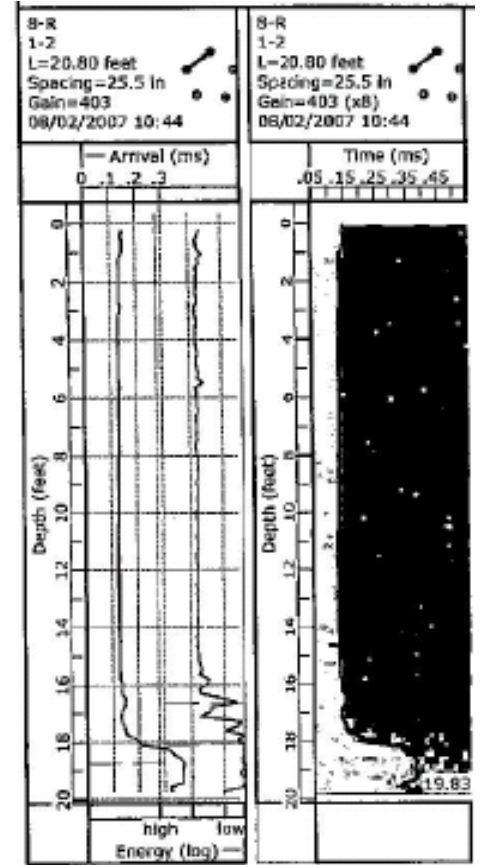
Figure 1-4 CSL results identifying only end defect.

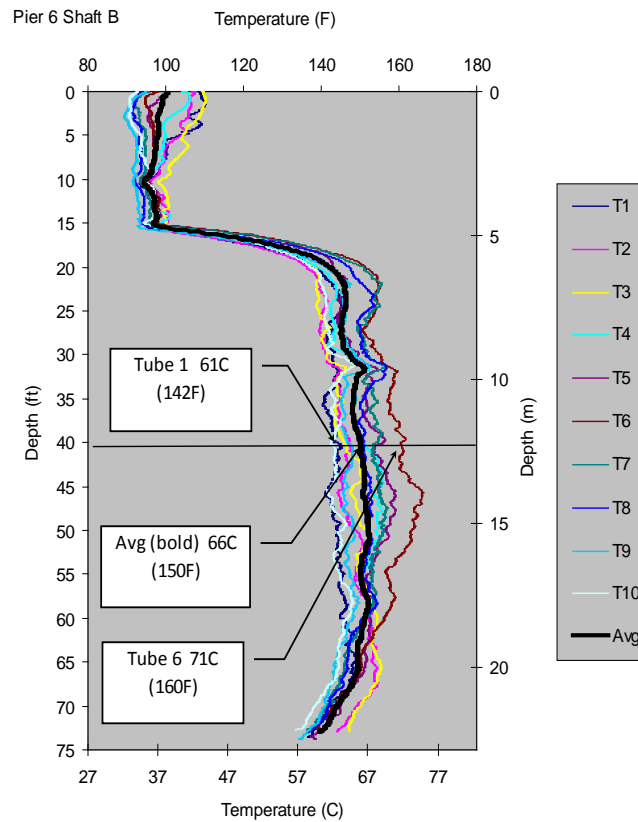
Figure 3-18 Thermal integrity profile of 10ft diameter shaft.

The data shown in Figure 3-18 was collected from the 10ft diameter shaft (with 10 access tubes) constructed in Tacoma, Washington as part of the I-5 / SR16, Nalley Valley Project discussed later in Chapter 4. Using a Level 1 approach, features of the as-built shaft geometry become recognizable. For instance, the water table was at 32ft and caused some sloughing before slurry was fully introduced which is seen in all tubes as being slightly warmer (bulge). The upper 15ft of measurements represent the access tube stick up above the top of shaft which does not affect the analysis but verifies field observations. The top and bottom of shaft show the normal effect of both radial and longitudinal temperature dissipation which extends a distance roughly 1 diameter down and up from the respective boundaries. At mid shaft elevations, dissipation is purely radial so a uniform shaft in uniform soil should register as straight line (vertical) profiles. Additionally, the cage alignment over the length of the shaft is obtained by comparing opposite side tubes and the change in temperature relative to the average. The amount of cage offset can be determined using the Figure 3-17 information.

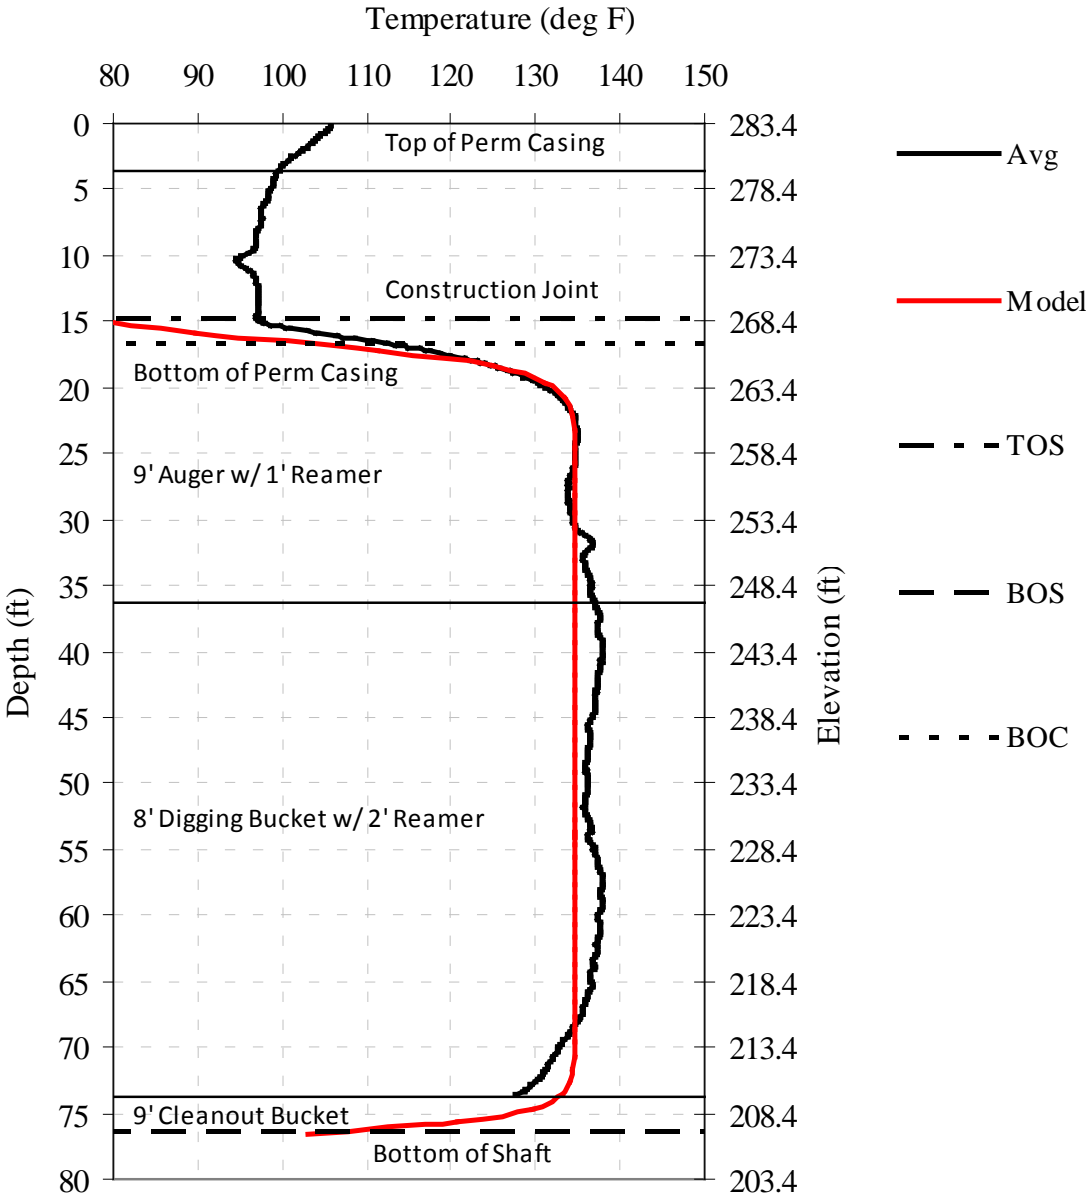
Figure 4-7 Measured and modeled temperature versus depth (Nalley Valley Pier 6 Shaft A).

The testing was performed on July 27, 2009 approximately 73 hours after concreting Shaft A. Field measurements were taken from each of the nine tubes (tube 9 was blocked and not tested) and are presented in Figure 4-6. A model was run based on theoretical shaft dimensions (10 ft diameter) and compared to the field measurements (Figure 4-7). The average field temperature from an elevation of 213ft to the bottom of shaft is less than the predicted model response. This indicates a smaller diameter shaft in this region, which is reasonable when compared to the construction logs. The construction log shows the use of a 9ft diameter cleanout bucket for approximately the last 4ft of excavation. This would cause a lower temperature as seen in the field data.

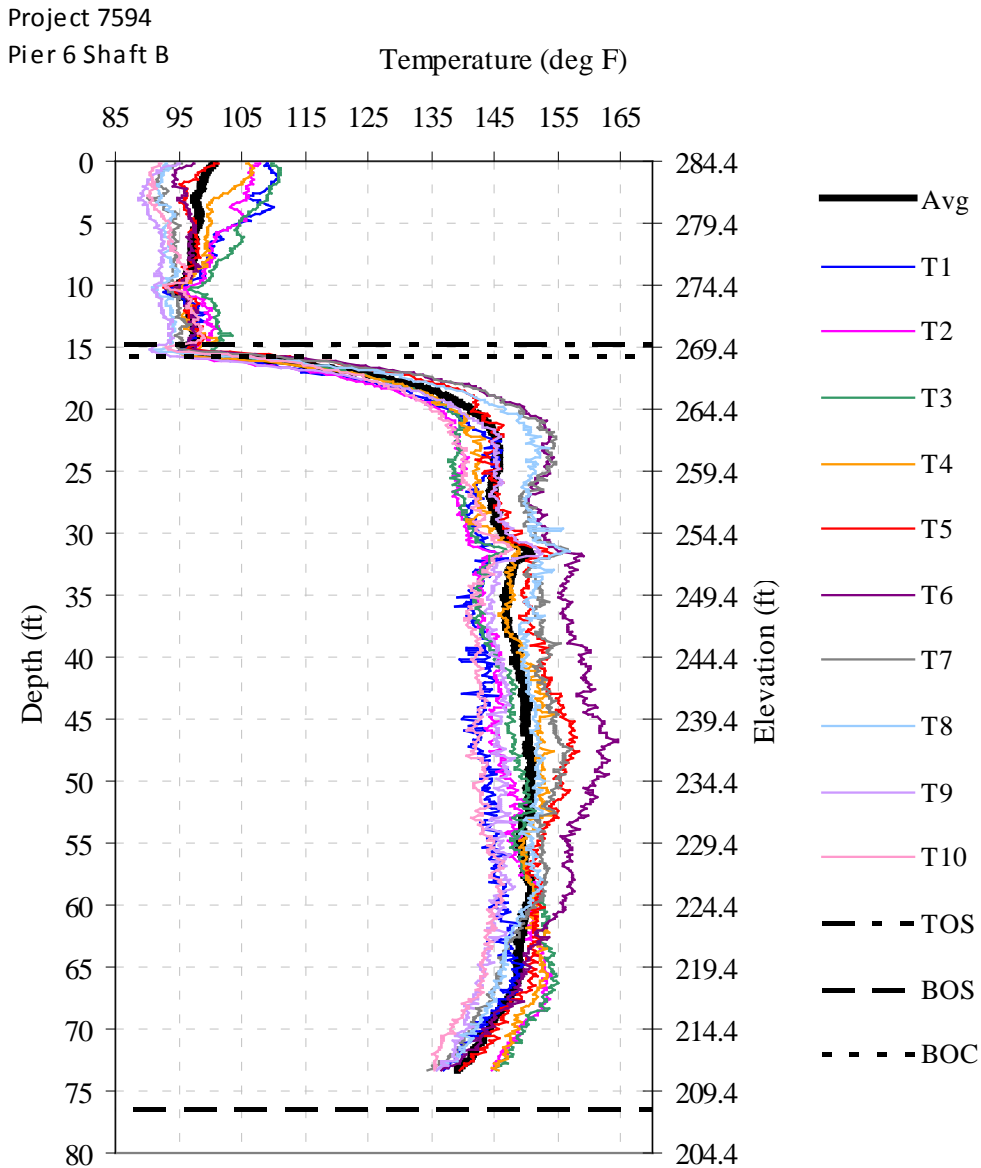
The testing was performed on July 30, 2009 approximately 52 hours after concreting Shaft B. Field measurements were taken from each of the ten tubes and are presented in Figure 4-11. To verify the thermal model predictions, thermocouples, T/C, were installed and monitored in Pier 6 Shaft B. A total of 6 T/C were installed on the reinforcement cage 6ft, 16ft, 26ft, 36ft, 46ft, and 56ft from the toe with a 7[th] T/C monitoring the air temperature. Figure 4-12 (top) shows the thermocouple data compared to the model temperature prediction.

Figure 4-11 Measured tube temperatures versus depth (Nalley Valley Pier 6 Shaft B).

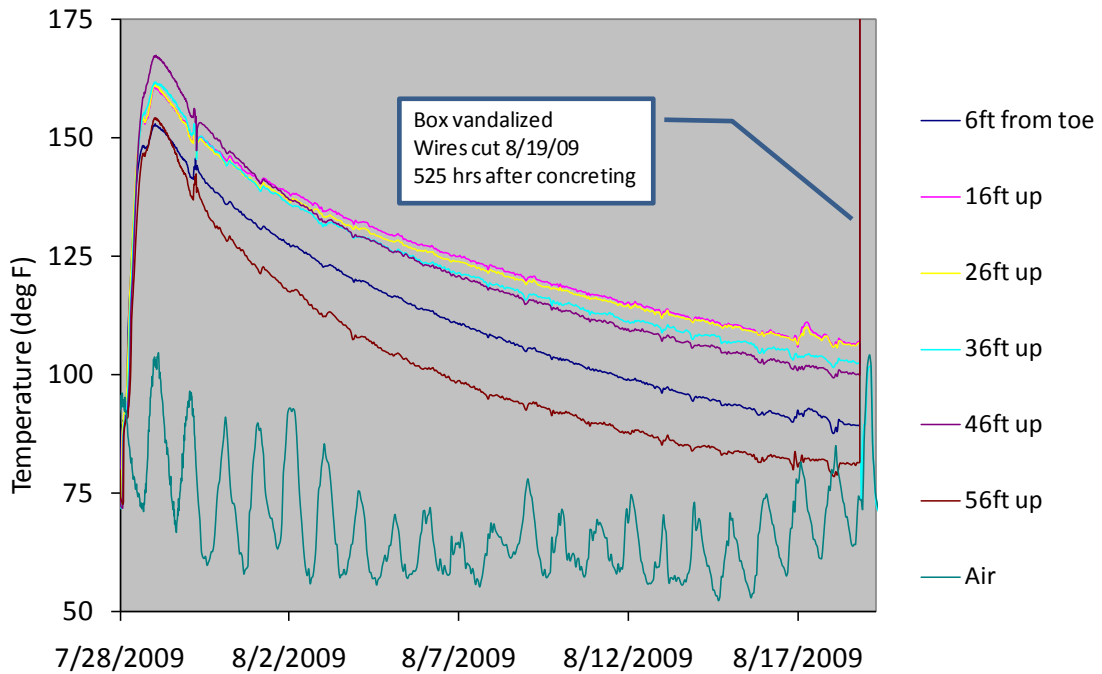
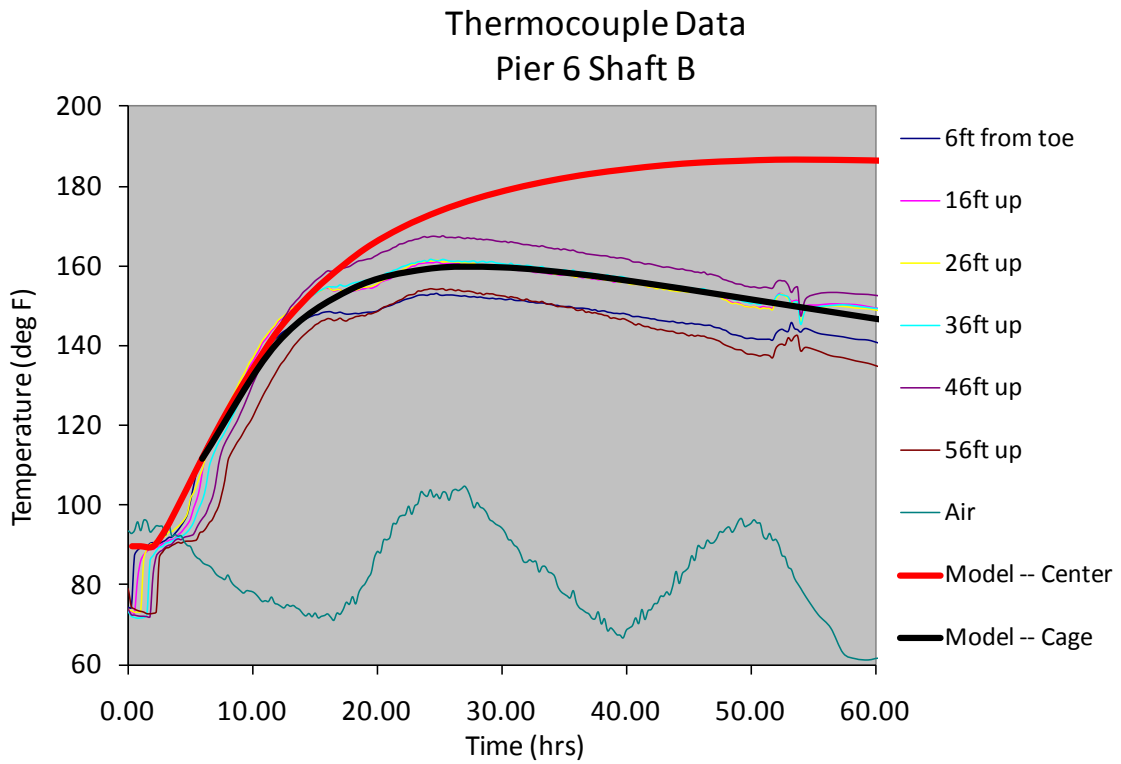
Figure 4-12 Thermocouple data for Pier 6 Shaft B compared with model response (top); elevated temperatures in shaft over 3 wk sampling period (bottom).

Thermocouple data collection was continued which showed elevated temperatures existed for at least 3 weeks (525 hrs) after concreting. A model was run based on theoretical shaft dimensions (10 ft diameter) and compared to the field measurements (Figure 4-13). The average field temperature is either in line with or greater than the model indicating an effective shaft diameter of 10ft or greater. Figure 4-14 shows the average measured temperature versus the concrete placement log. The effective radius (Figure 4-15) is predicted without axial heat dissipation corrections. Figure 4-16 shows a 3-D rendered image of the as-built shaft.

recommended. However, a better understanding of the temperature generation can be obtained through either pre-test modeling or a pilot study performed early-on in a given project. Such a study was performed for the Nalley Valley project (Figure 4-12) whereby embedded temperature sensors where installed and monitored for an extended period of time after concreting. Pilot programs provide a realistic time frame for testing shafts of similar sizes with the same mix design as well as confirm the model validity for predicting internal temperatures of all shaft sizes and various times of testing. The new extension of thermal testing capabilities using embedded thermal wires (discussed in Section 5.5) is one way of both performing a pilot program while also obtaining sufficient data to assess the shaft integrity. The criterion for acceptable testing times is established such that a sufficient gradient exists between those materials that generate heat and those that do not. In the Washington State area, average soil temperatures are near 50F. So, even at the nominal 110F observed concrete temperatures a considerable gradient still existed.

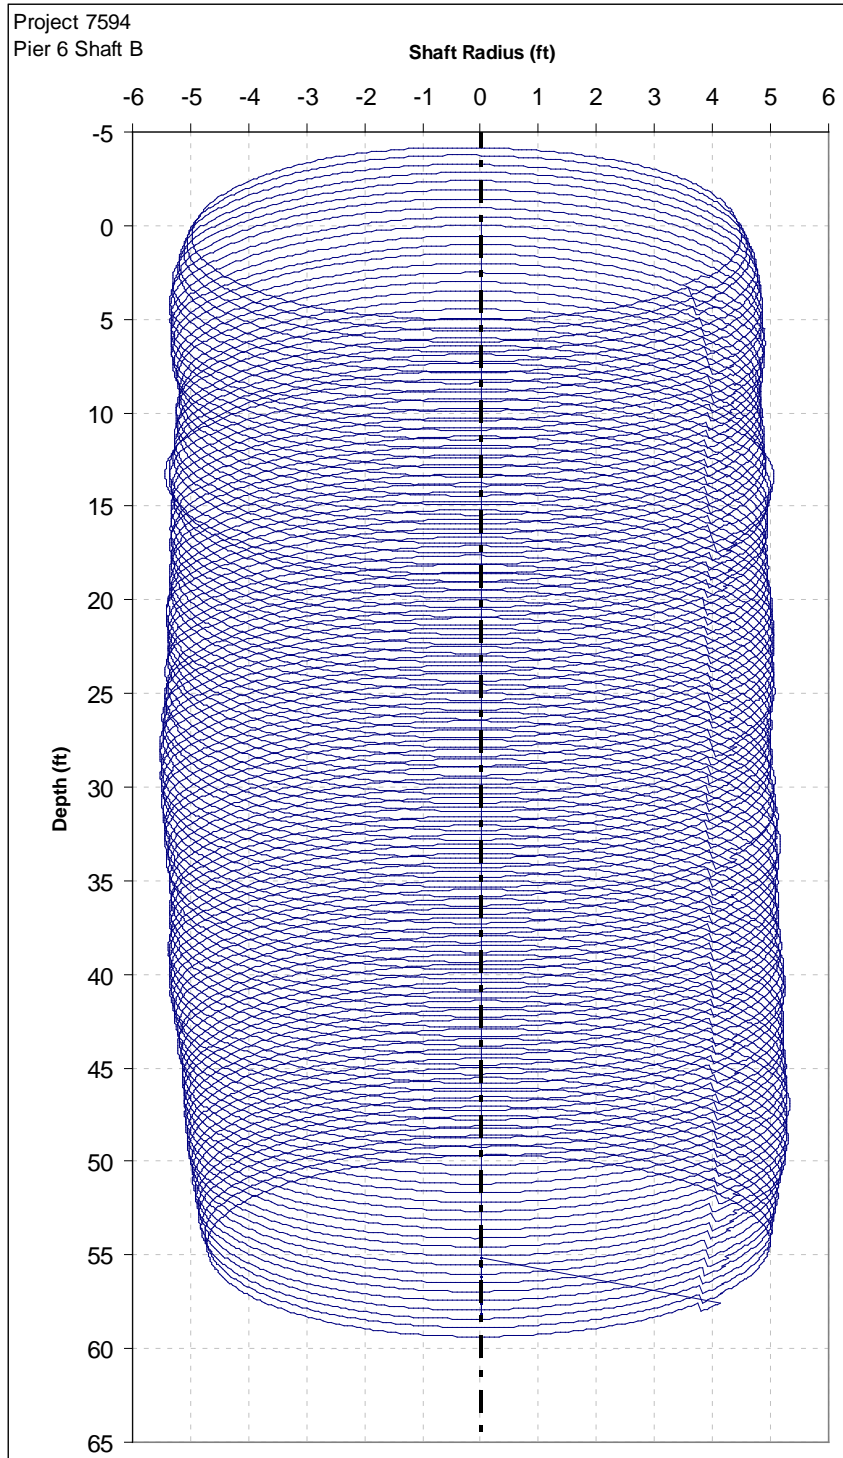
Figure 4-16 3-D rendering from tube spacings and effective radius calculations (Nalley Valley Pier 6 Shaft B).

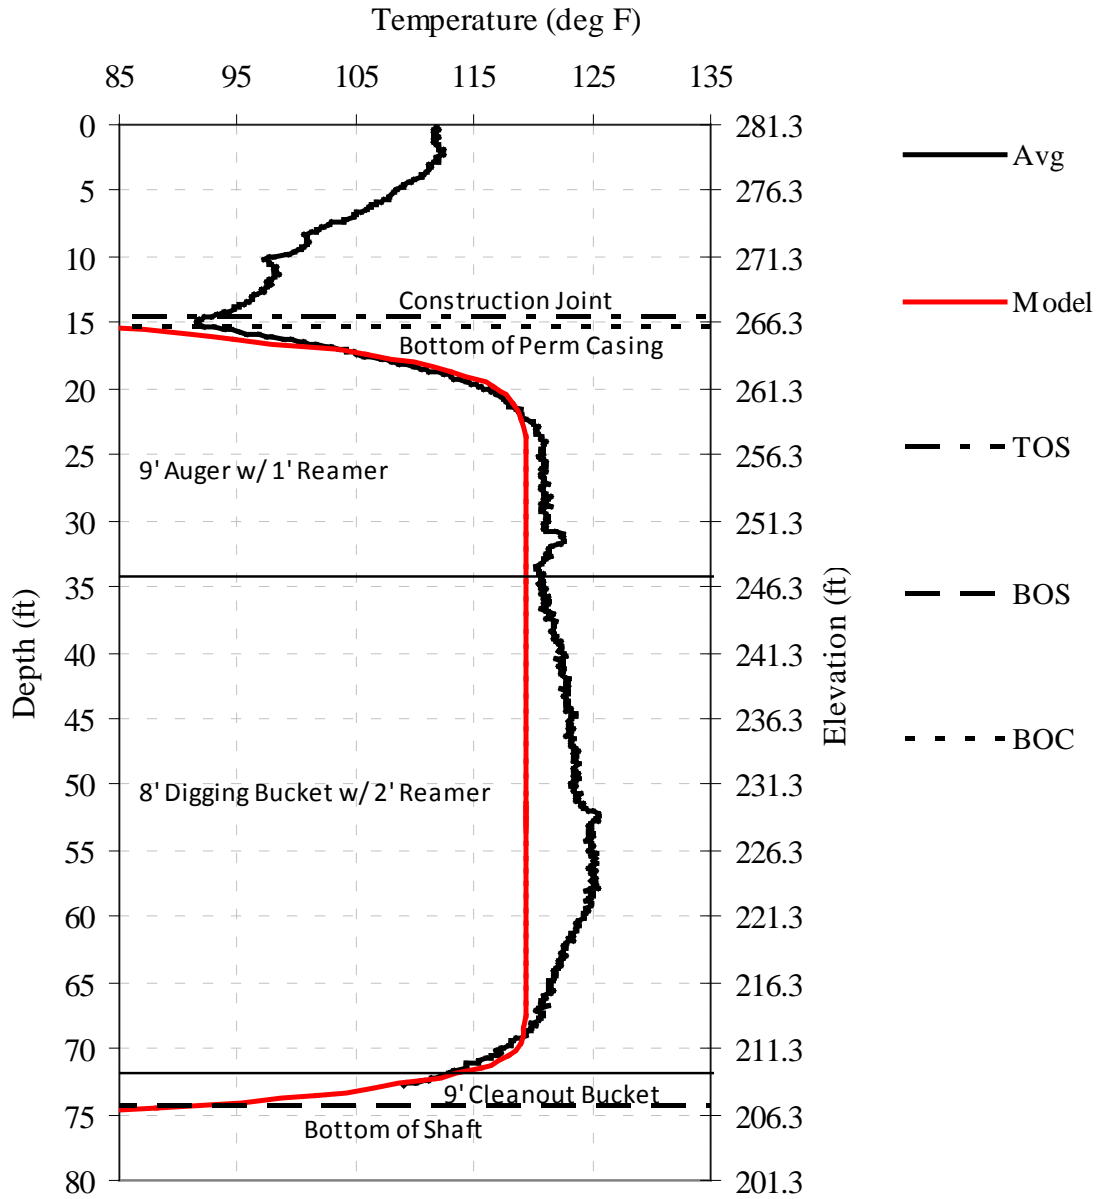
Figure 4-18 Measured and modeled temperature versus depth (Nalley Valley Pier 6 Shaft C).

- The average field temperature is either in line with or greater than the model indicating an effective shaft diameter of 10ft or greater throughout.
- The reinforcement cage alignment varies (up to approximately 2 inches) throughout the length of the shaft.

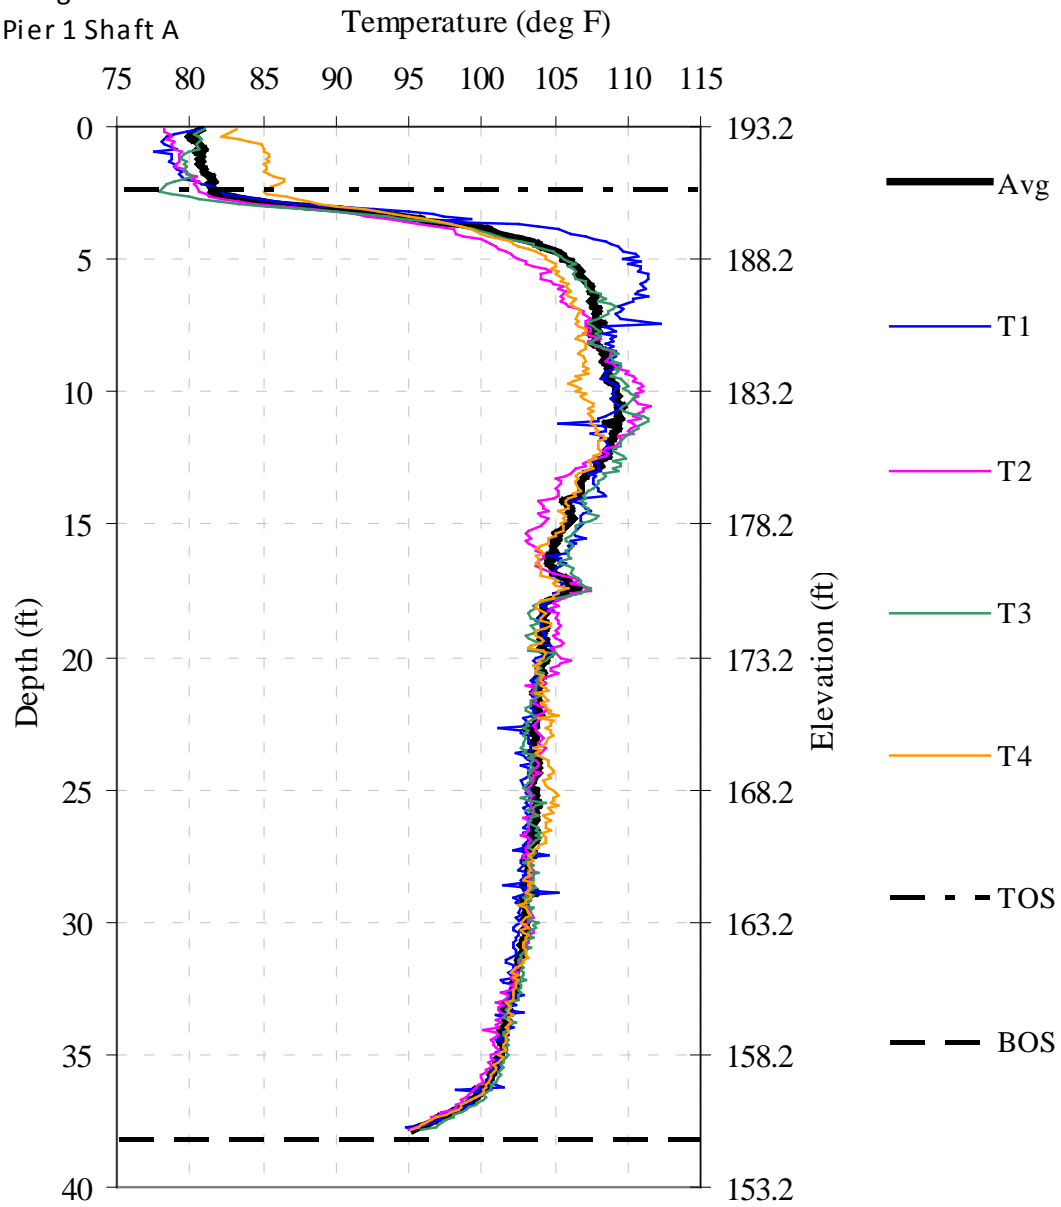
Figure 4-26 Measured tube temperatures versus depth (Scatter Creek Pier 1 Shaft A).

The testing was performed on August 4, 2009 approximately 50 hours after concreting Shaft A. Field measurements were taken from each of the four tubes and are presented in Figure 4-26. A model was run based on theoretical shaft dimensions (4 ft diameter) and compared to the field measurements (Figure 4-27). The average field temperature is either in line with or greater than the model indicating an effective shaft diameter of 4ft or greater.

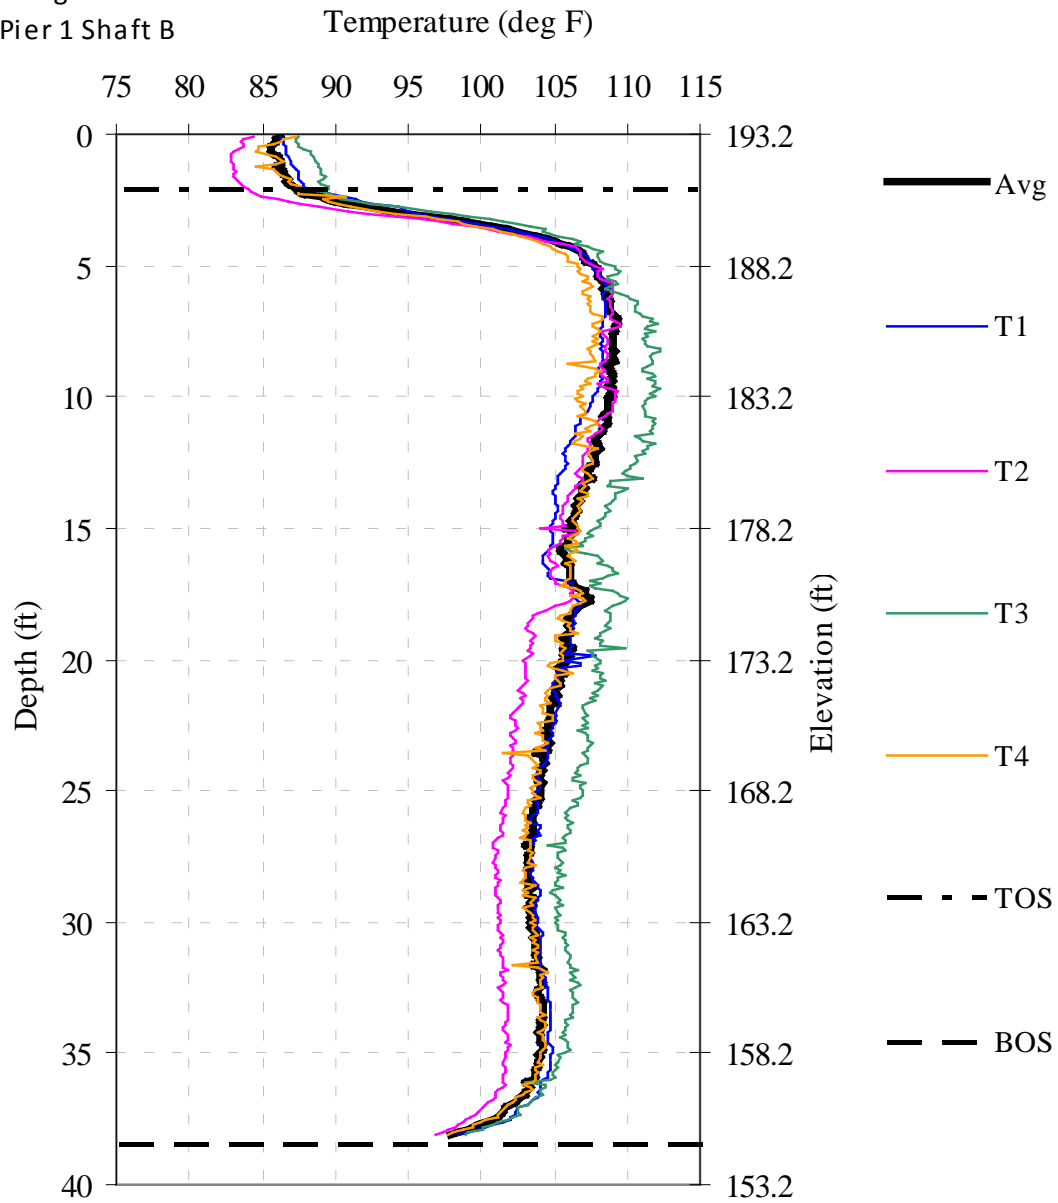
Figure 4-28 Measured tube temperatures versus depth (Scatter Creek Pier 1 Shaft B).

The testing was performed on August 4, 2009 approximately 52 hours after concreting Shaft B. Field measurements were taken from each of the four tubes and are presented in Figure 4-28. A model was run based on theoretical shaft dimensions (4 ft diameter) and compared to the field measurements (Figure 4-29). The average field temperature is either in line with or greater than the model indicating an effective shaft diameter of 4ft or greater.

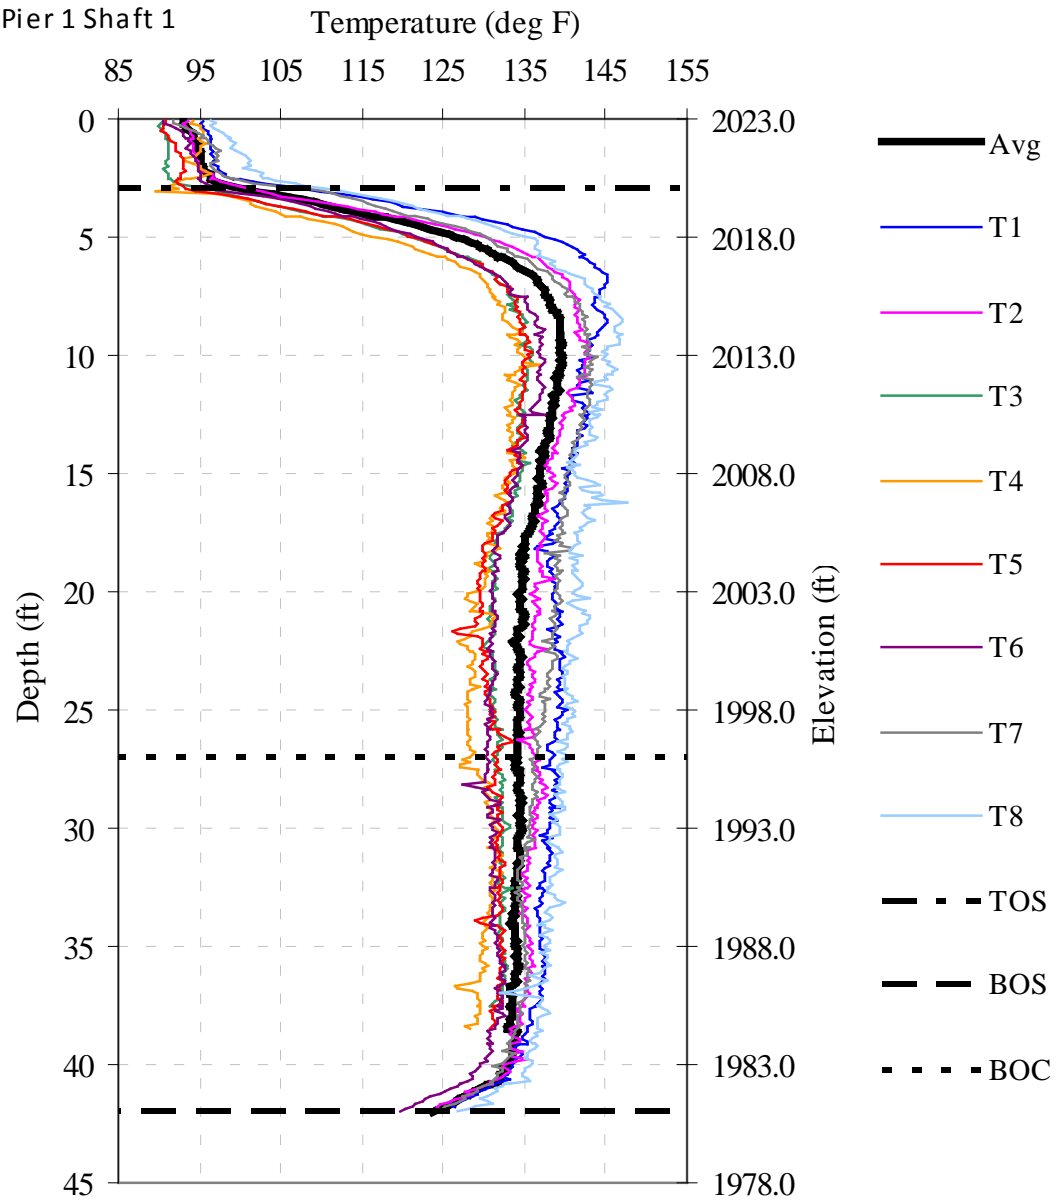
Figure 4-34 Measured tube temperatures versus depth (Tieton River Pier 1 Shaft 1).

The testing was performed on August 11, 2009 approximately 25 hours after concreting Shaft 1. Field measurements were taken from each of the eight tubes and are presented in Figure 4-34. A model was run based on theoretical shaft dimensions (8 ft diameter) and compared to the field measurements (Figure 4-35). The average field temperature is either in line with or greater than the model suggesting a shaft with a diameter 8ft or greater.

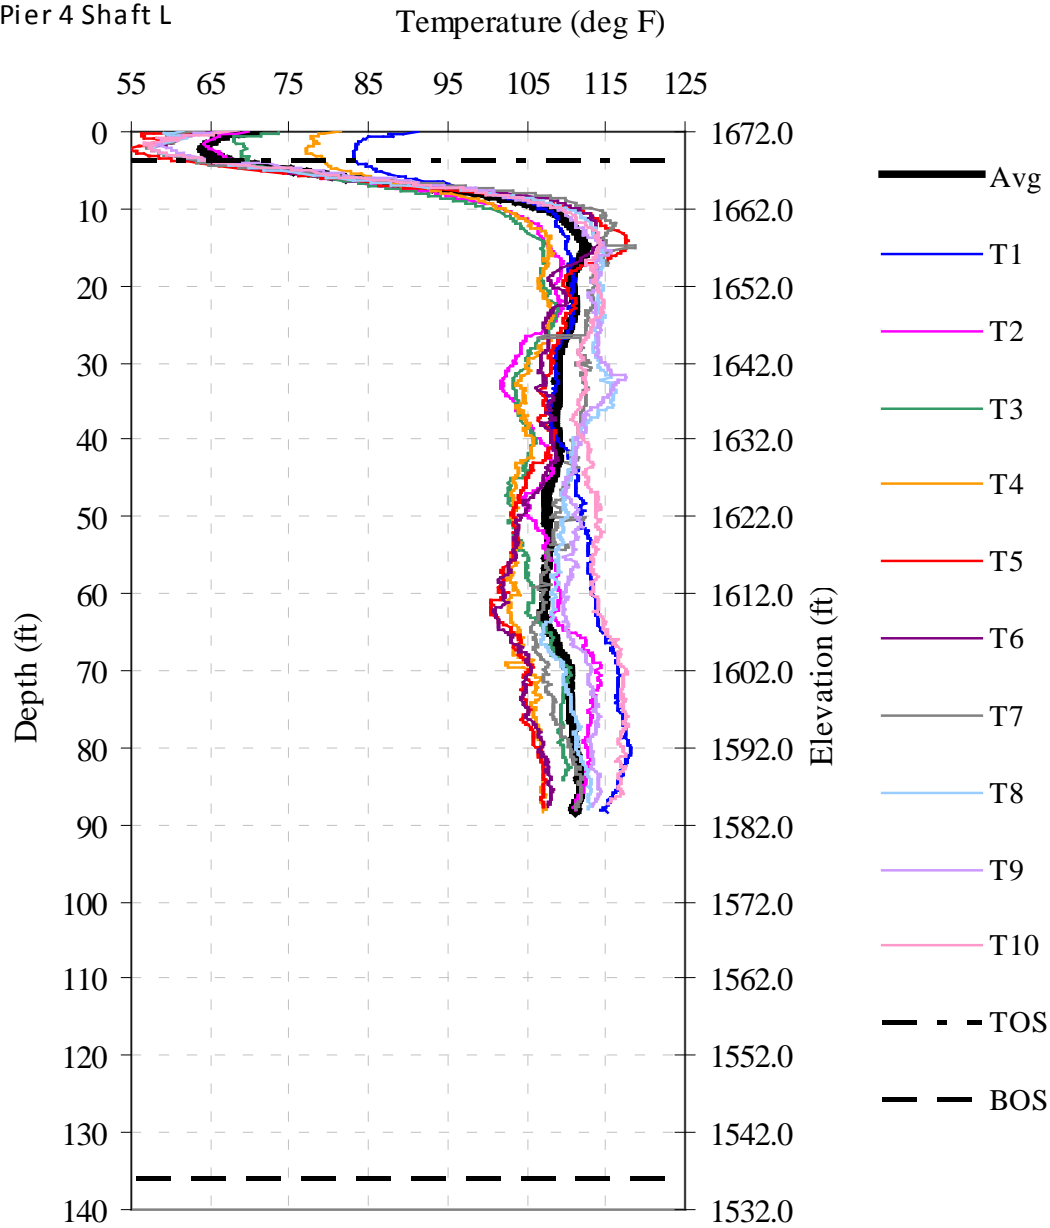
Figure 4-40 Measured tube temperatures versus depth (US 395 Wandermere Pier 4 Shaft L).

The testing was performed on January 13, 2010 approximately 383 hours after concreting Shaft L. Field measurements were taken from each of the ten tubes and are presented in Figure 4-40. The shaft was constructed to a length of 132ft; however, field measurements were only taken to a depth of approximately 90ft. The plans show the shaft to be a step shaft from 10ft diameter down to a 6ft diameter rock socket. It is likely that the reinforcement cage design limited the access of the rock socket.

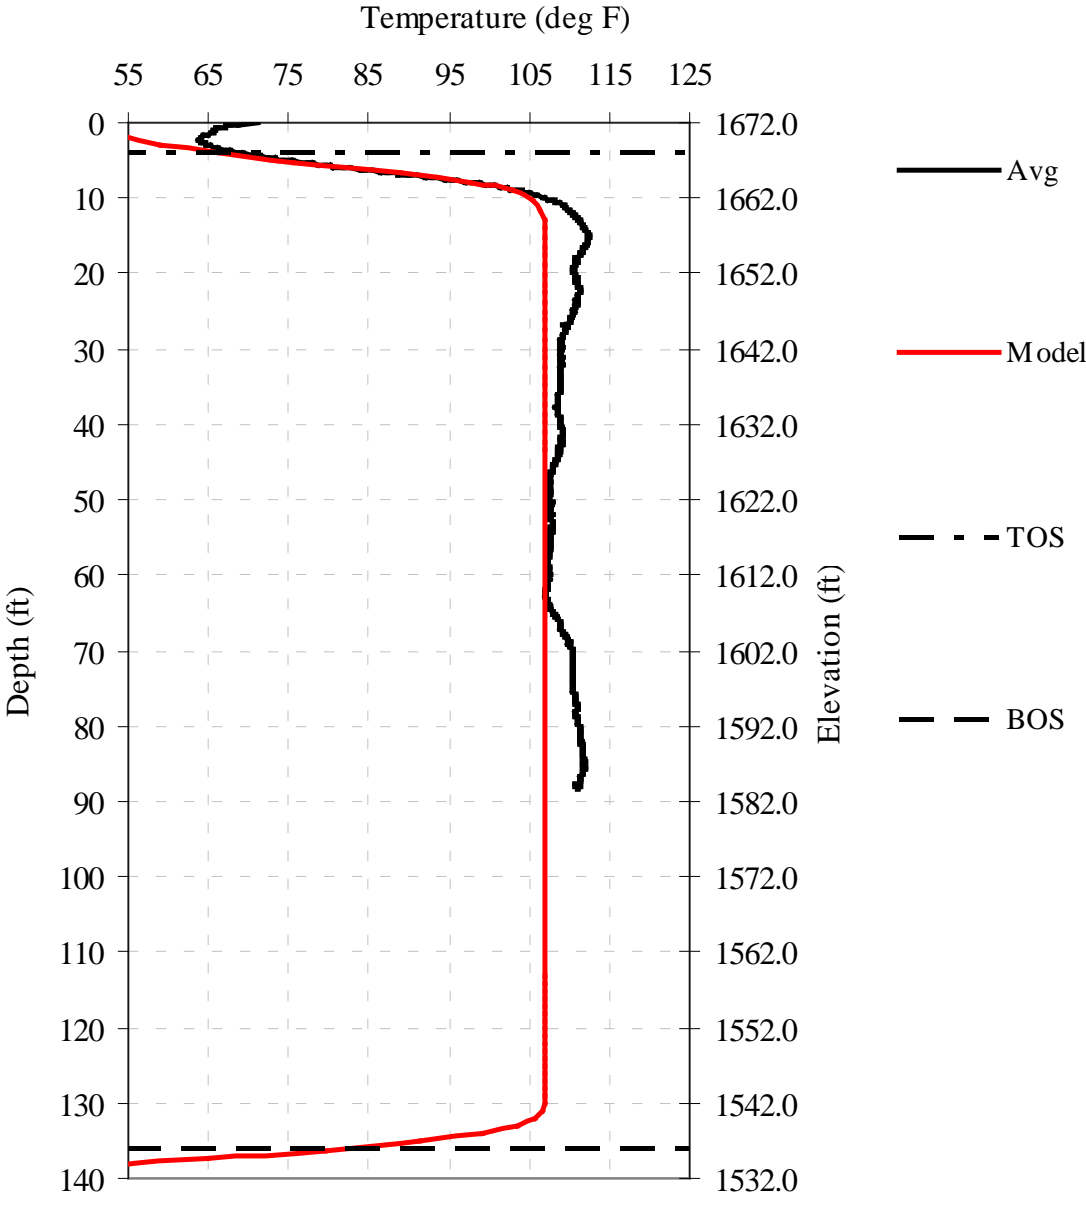
Figure 4-41 Measured and modeled temperature versus depth (US 395 Wandermere Pier 4 Shaft L).

A model was run based on theoretical shaft dimensions (10 ft diameter) and compared to the field measurements (Figure 4-41). The average field temperature is either in line with or greater than the model indicating an effective shaft diameter of 10ft or greater for the tested shaft length. Figure 4-42 shows the average measured temperature versus the concrete placement log. The effective radius (Figure 4-43) is predicted without axial heat dissipation corrections. Figure 4-44 shows a 3-D rendered image of the as-built shaft.

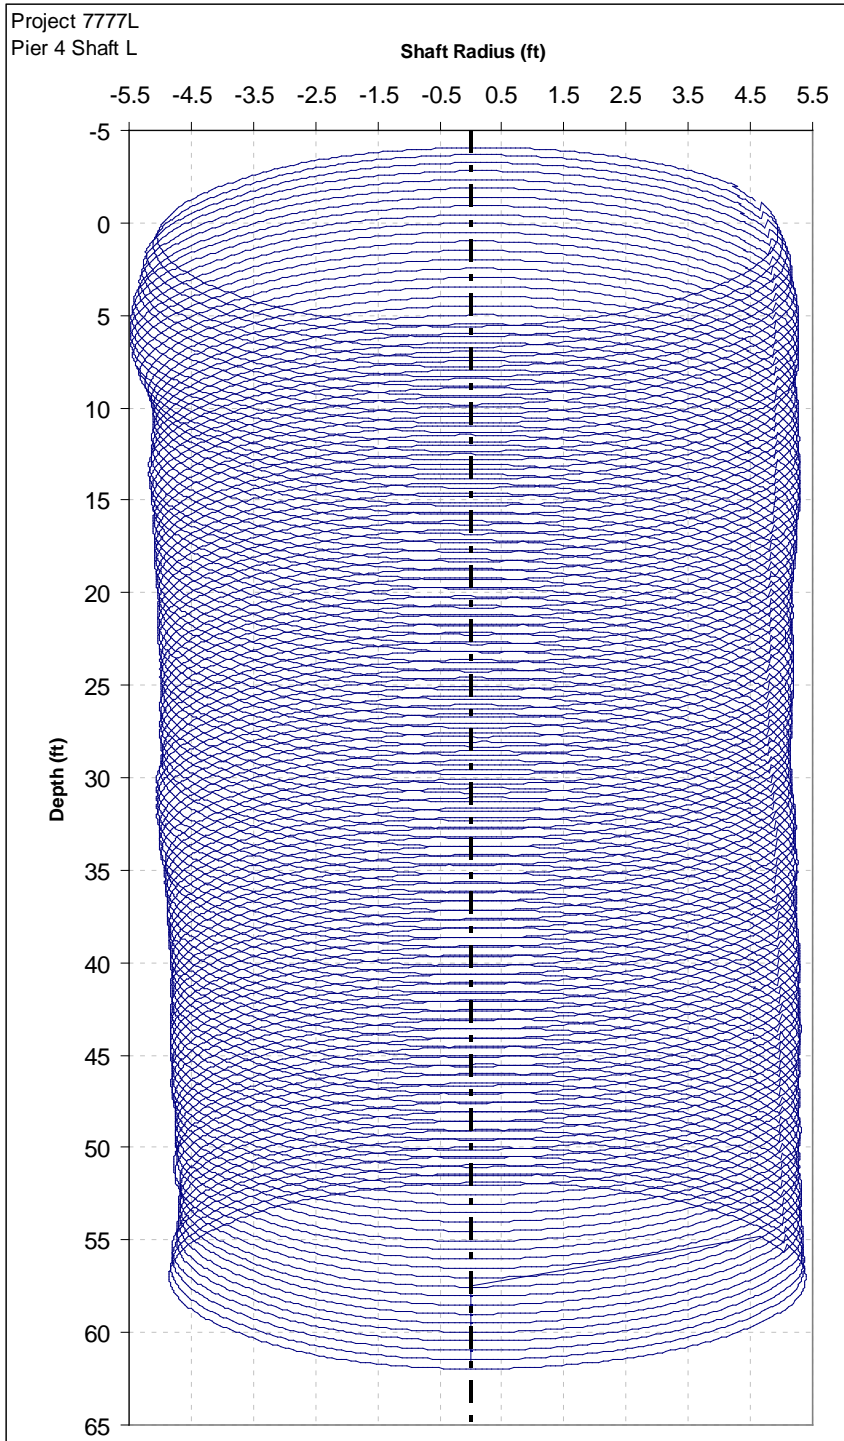
Figure 4-44 3-D rendering from tube spacings and effective radius calculations (US 395 Wandermere Pier 4 Shaft L).

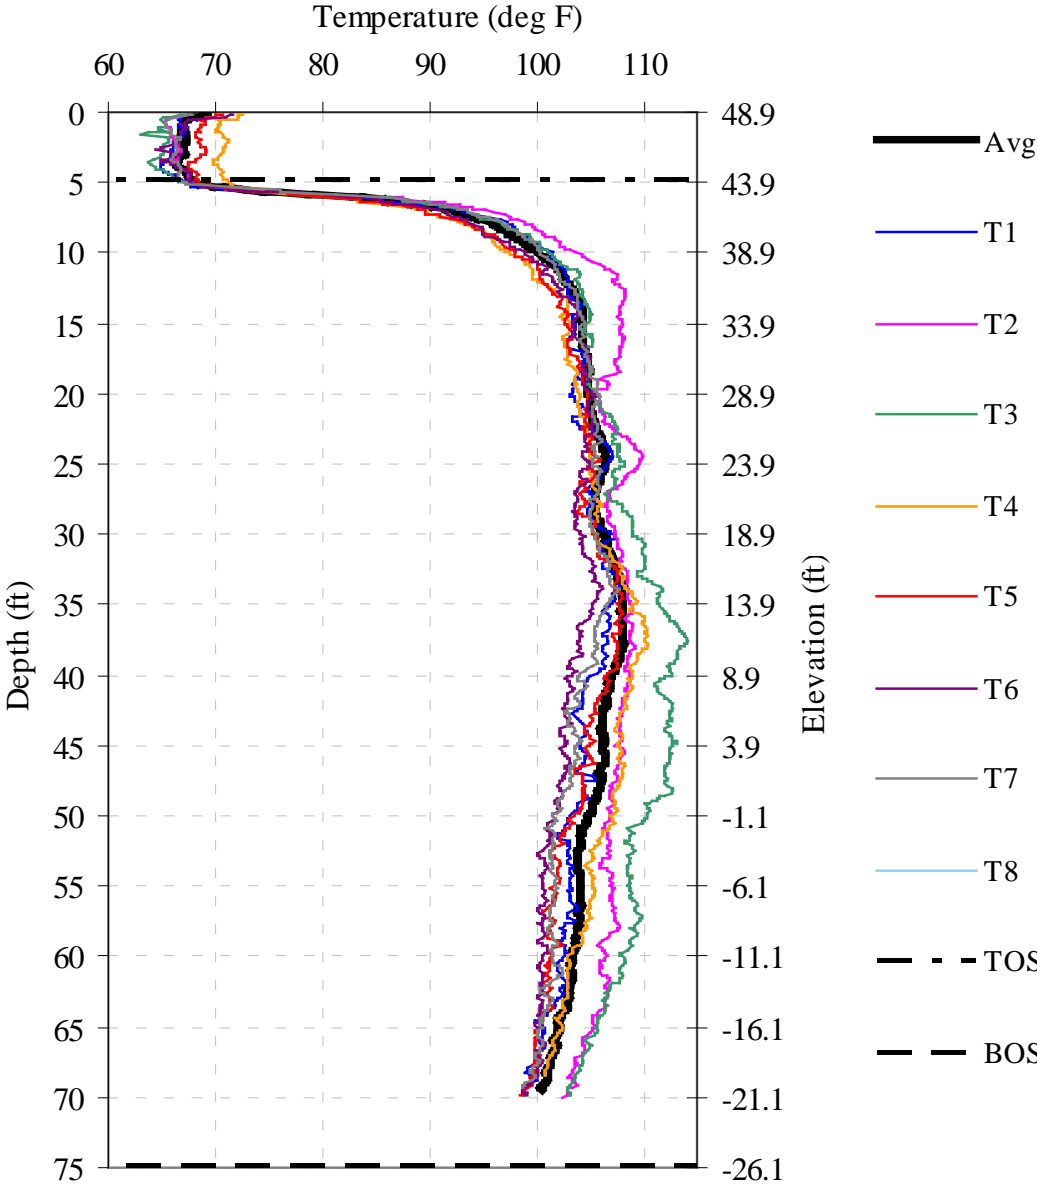
Figure 4-49 Measured tube temperatures versus depth (Vancouver Rail Pier 2 Shaft N).

The testing was performed on February 24, 2010 after construction of the North shaft. Field measurements were taken from each of the seven tubes and are presented in Figure 4-49. A model was run based on theoretical shaft dimensions (6.5 ft diameter) and compared to the field measurements (Figure 4-50). The average field temperature is either in line with or greater than the model indicating an effective shaft diameter of 6.5ft or greater. However, either the tubes did not extend to the bottom of the shaft (leaking or blockages) or the shaft was excavated beyond the cage which is visible in the profiles due to no toe roll-off.

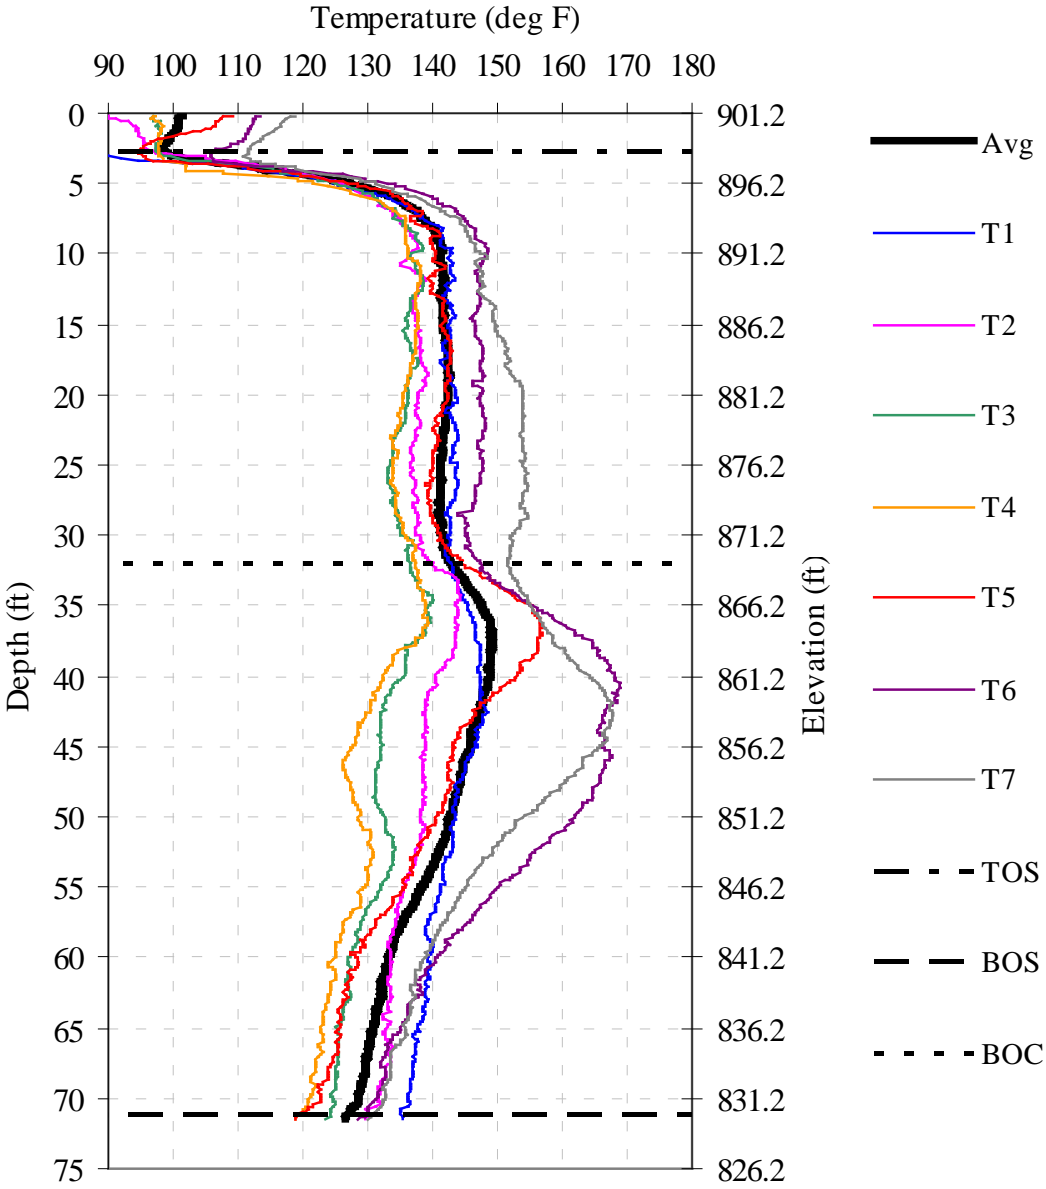
Figure 4-54 Measured tube temperatures versus depth (Gallup River Pier 1 Shaft S).

The testing was performed on August 1, 2010 approximately 40 hours after concreting the South shaft. Field measurements were taken from each of the seven tubes and are presented in Figure 4-54. Field measurements indicate a uniform shaft within the cased region with the reinforcement cage alignment varying. Below the casing, there is a large bulge in the direction of tubes 6 and 7. A model was run based on theoretical shaft dimensions (7 ft diameter) and compared to the field measurements (Figure 4-55). The average field temperature is either in line with or greater than the model indicating an effective shaft diameter of 7ft or greater from an approximate elevation of +898 to +839. From an approximate elevation of +839 to +830, the average temperature is lower than the model prediction indicating an effective shaft diameter less than 7ft. Figure 4-56 shows the average measured temperature versus the concrete placement log. The effective radius (Figure 4-57) is predicted without axial heat dissipation corrections. This shaft has a large range of radii (and average temperatures) due to the bulge from which a temperature-to-radius correlation developed (Multi-Truck Method). Figure 4-58 shows a 3-D rendered image of the as-built shaft based on temperature-to-radius correlations.

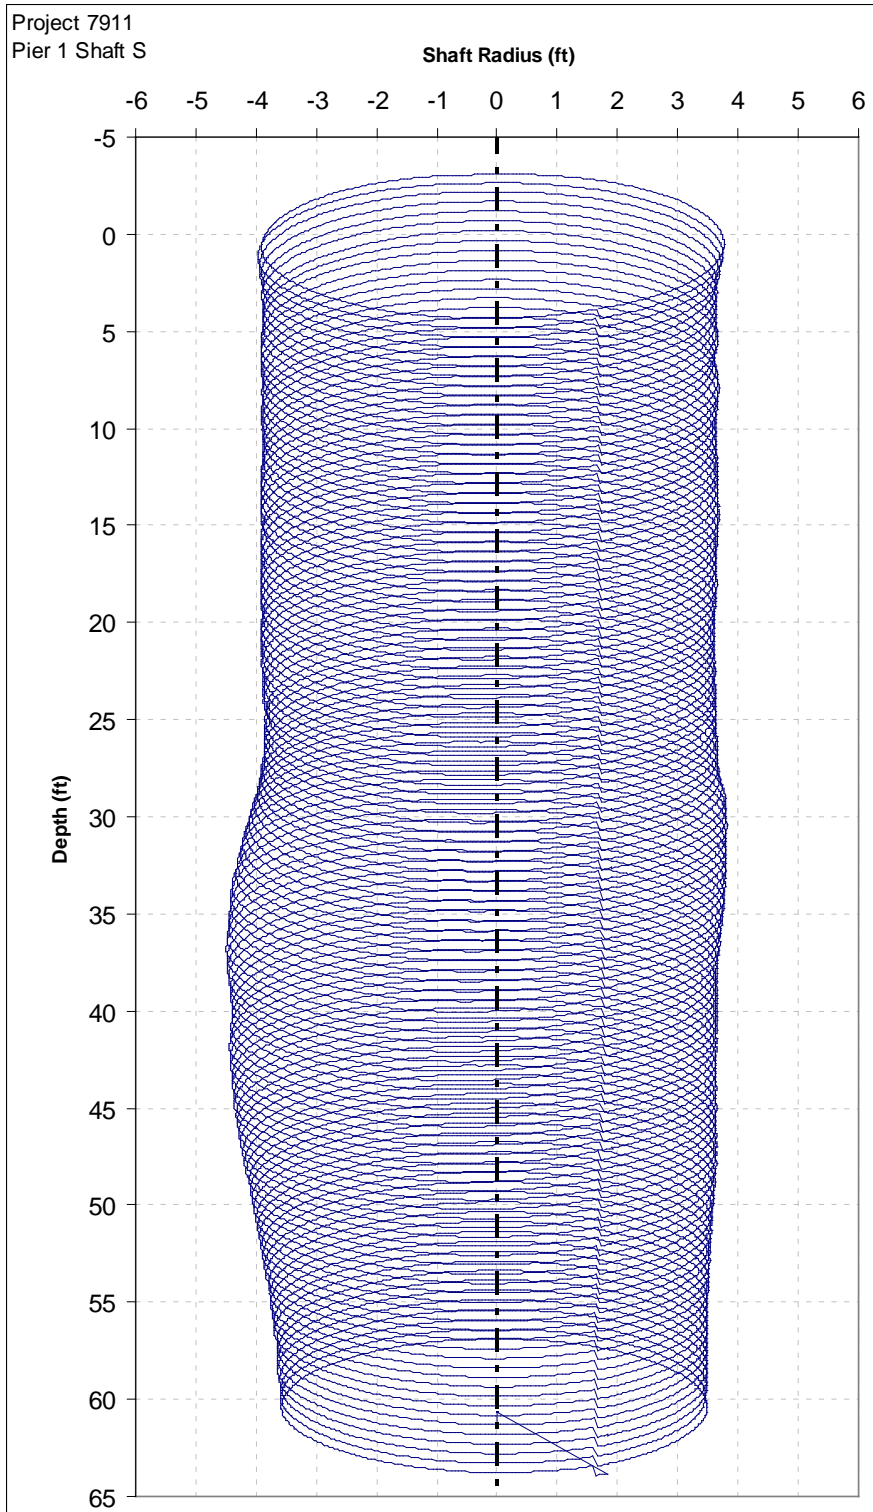
Figure 4-58 3-D rendering from tube spacings and effective radius calculations (Gallup River Pier 1 Shaft S).
