# Infrared Thermal Integrity Testing Quality Assurance Test Method to Detect Drilled Shaft Defects

WSDOT Research Report

FINAL REPORT

1. REPORT NO. **WA-RD 770.1**	2. GOVERNMENT ACCESSION NO.	3. RECIPIENTS CATALOG NO
4. TITLE AND SUBTITLE Infrared Thermal Integrity Testing Quality Assurance Test Method To Detect Drilled Shaft Defects		5. REPORT DATE *June 2011*
		6. PERFORMING ORGANIZATION CODE
7. AUTHOR(S) G. Mullins and D. Winters		8. PERFORMING ORGANIZATION REPORT NO.
9. PERFORMING ORGANIZATION NAME AND ADDRESS University of South Florida 4202 E. Fowler Avenue Tampa, FL 33620		10. WORK UNIT NO.
		11. CONTRACT OR GRANT NO. GCA5855
12. CO-SPONSORING AGENCY NAME AND ADDRESS Washington State Department of Transportation Transportation Building, MS 47372 Olympia, Washington 98504-7372 Research Manager: Kim Willoughby 360.705.7978		13. TYPE OF REPORT AND PERIOD COVERED *Final Report*
		14. SPONSORING AGENCY CODE

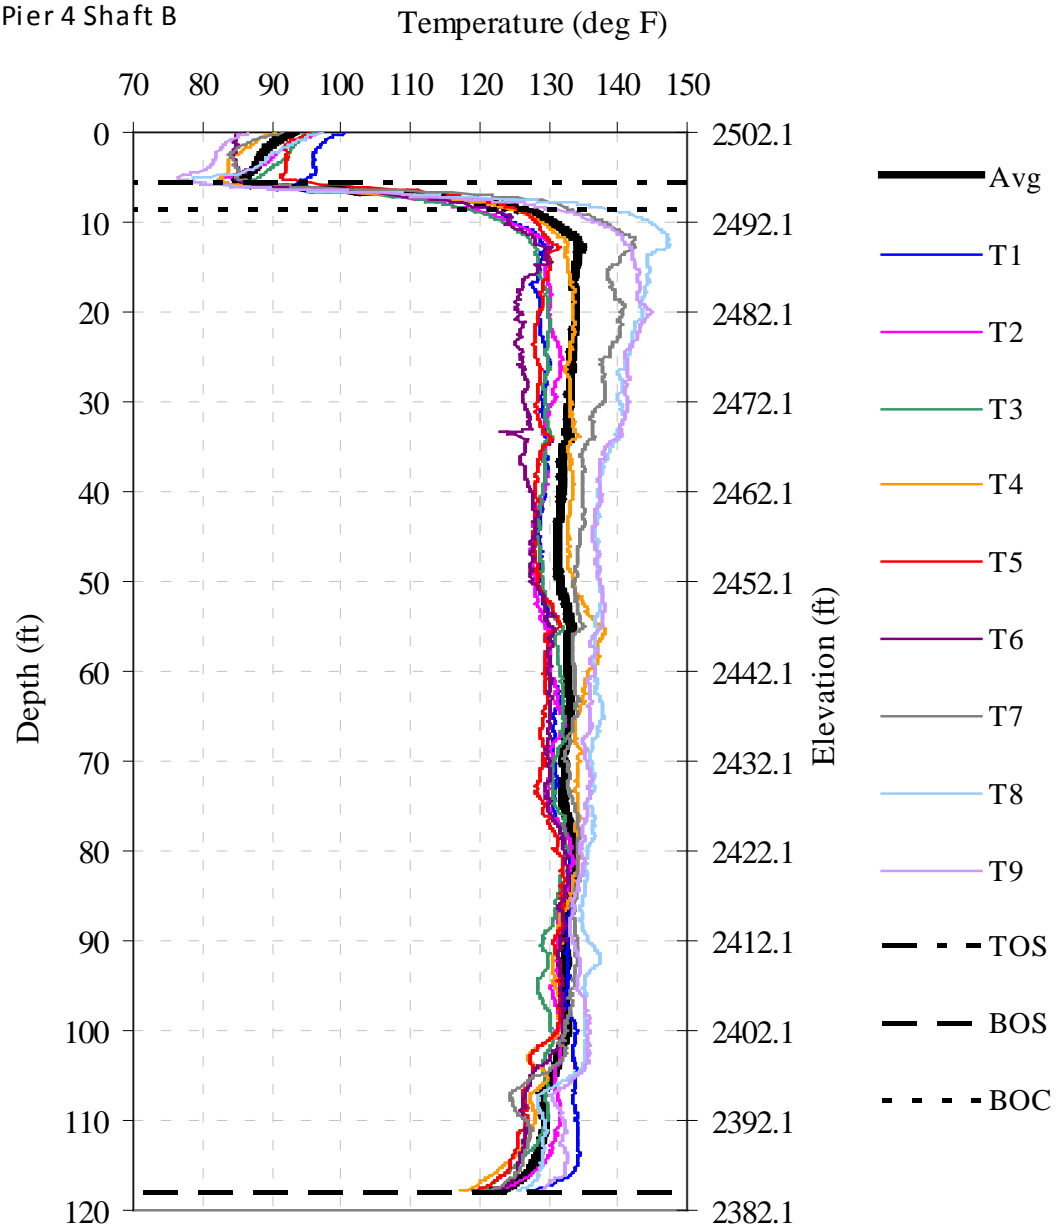
Figure 4-63 Measured tube temperatures versus depth (Hyak Pier 4 Shaft B).

The testing was performed on August 20, 2010 approximately 48 hours after concreting Shaft B. Field measurements were taken from each of the nine tubes and are presented in Figure 4-63. A model was run based on theoretical shaft dimensions (9 ft diameter) and compared to the field measurements (Figure 4-64). The average field temperature is either in line with or greater than the model indicating an effective shaft diameter of 9ft or greater from an approximate elevation of +2496 to +2387. From an approximate elevation of +2387 to +2382, the average temperature is lower than the model prediction indicating an effective shaft diameter less than 9ft. The reinforcement cage varies throughout the length of the shaft, as well. Figure 4-65 shows the average measured temperature versus the concrete placement log. The effective radius (Figure 4-66) is predicted without axial heat dissipation corrections. Figure 4-67 shows a 3-D rendered image of the as-built shaft.

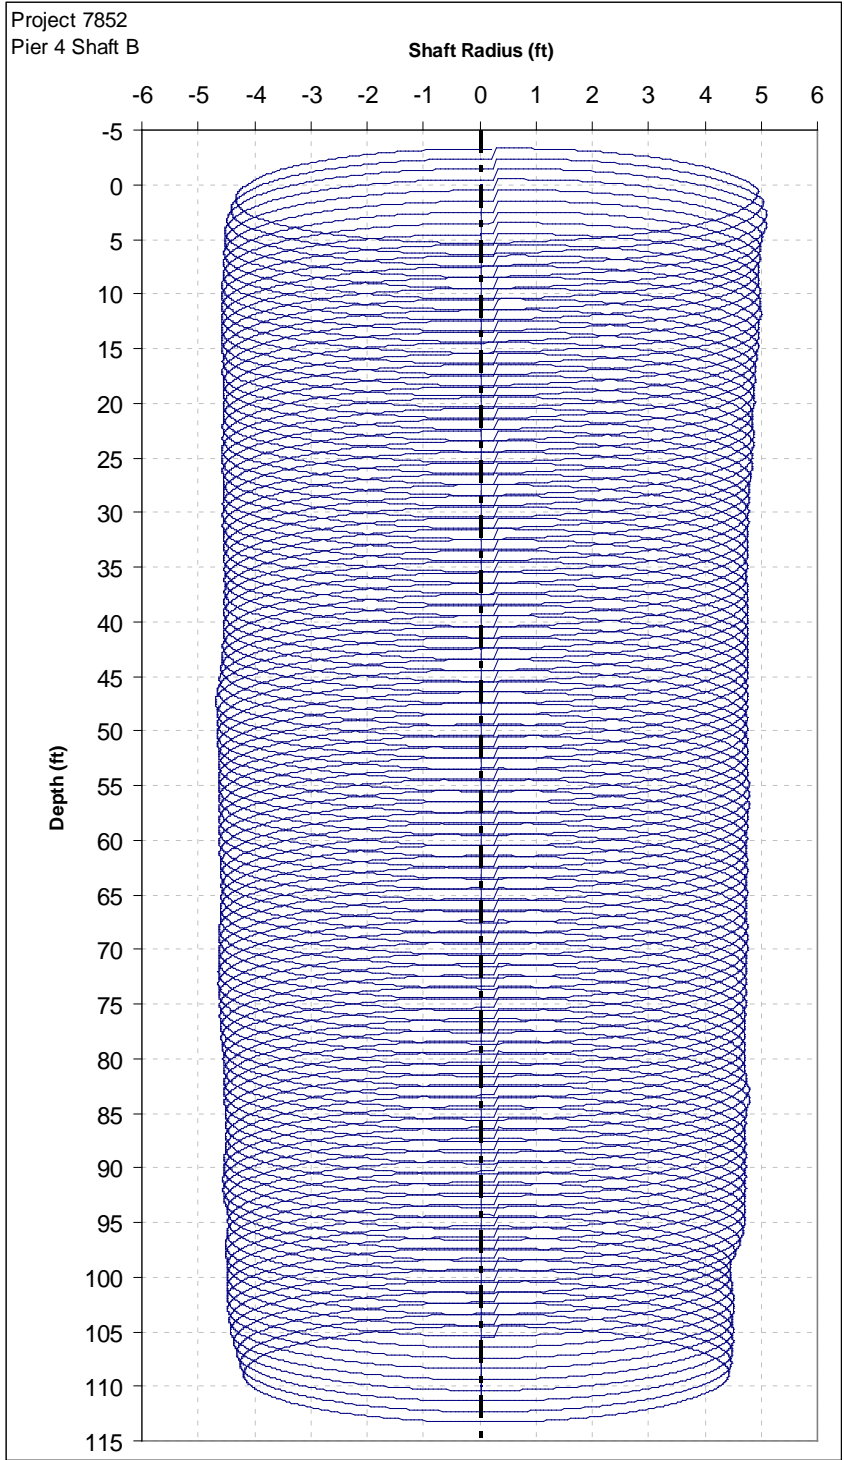
Figure 4-67 3-D rendering from tube spacings and effective radius calculations (Hyak Pier 4 Shaft B).
